Technical Bulletin

00 13 02 February 21, 2013 2032798 Supersedes TB V001301 dated January 29, 2013 to include additional instruction and remove Beetle convertible applicability.

Vehicle Delivery to the Dealer - By-Pack Inspection Process

Missing Items in the By-Pack at Vehicle Delivery to Dealer

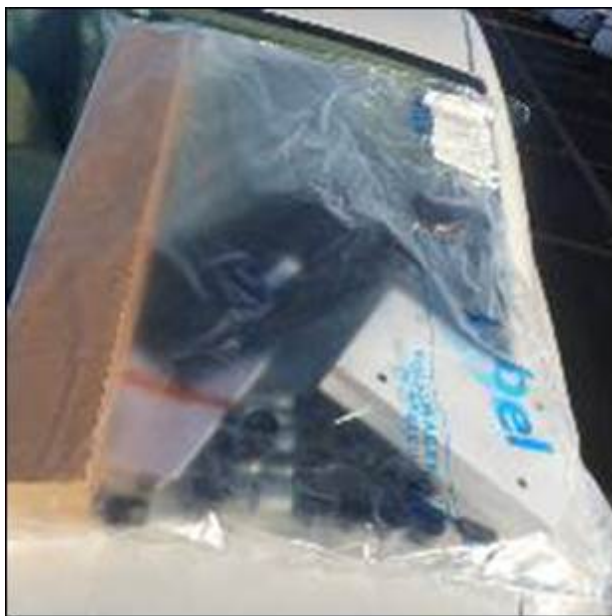
Figure 1

Yes – Clear pictures of the front and back of the unopened bag, as well as a picture of the label, need to be taken. (See Fig. 1, 2 & 3). The VIN must be legible in the picture of the label. Open VTA ticket and attach photos. **DO NOT OPEN** By-Pack bag.
