# Service Action

Code: 64C9

Subject: 2012 – 2013 MY Volkswagen Beetle  
Front Window Motors

**REVISION**

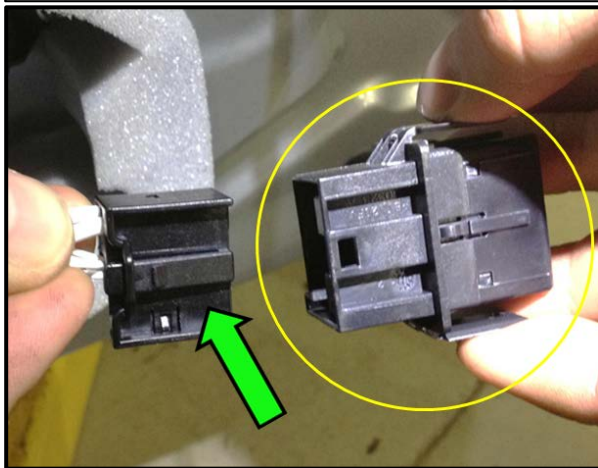
⚠ Note: On some of the old window motors there is an intermediate connector <circle> between the vehicle wiring harness <arrow> and the window motor itself. This piece is not used on the updated window motor and can be discarded.

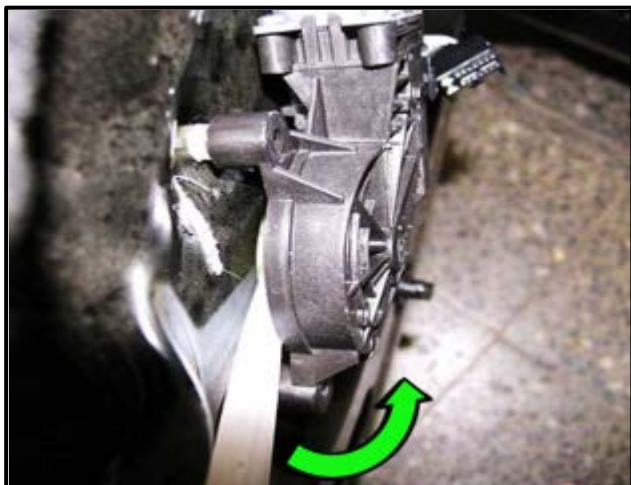
If regulator gear drum unseats or comes out too far, damage to regulator may occur.

- ⇐ With the aid of trim removal wedge <3409> or equivalent, carefully remove the window regulator motor straight out (not at an angle) from the mounts of the cable reel so that the regulator gear drum does not unseat from its housing.

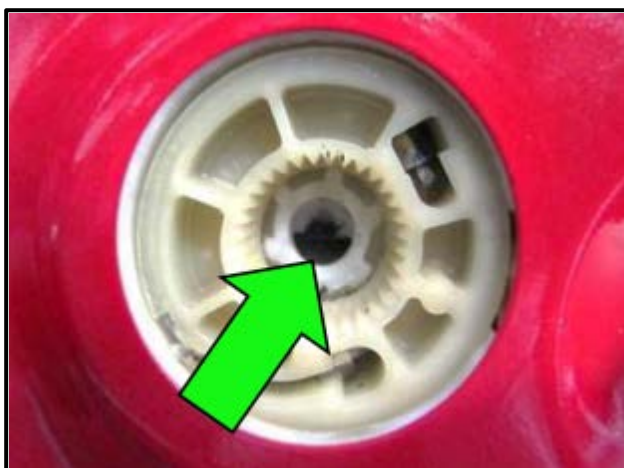
**CAUTION:** It is important that the adhesive remains only in the regulator bore and does not leak out onto the gear splines. Do not allow adhesive to come in contact with the regulator gear splines.

- ⇐ Place a large drop of adhesive part number (D 195 800 A1) as shown <arrow> into the lower corner of the regulator bore.

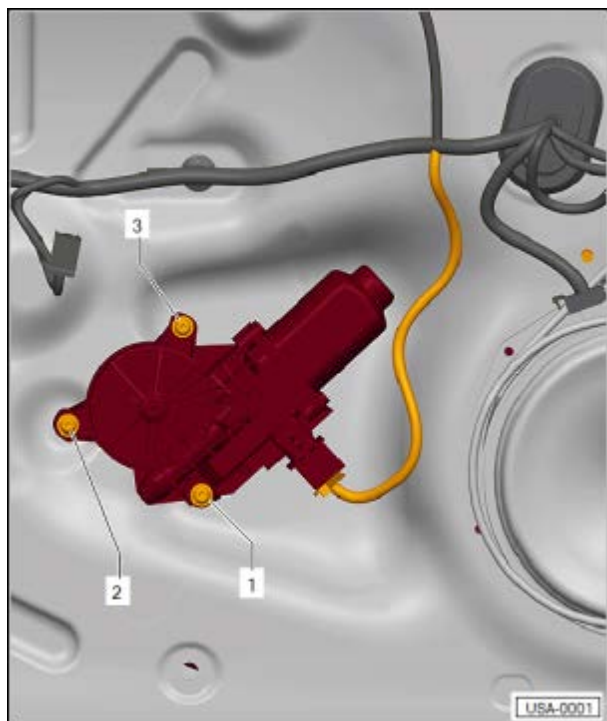
**Note: Critical Torque Sequence!**

It is very important to follow the specified torque sequence and specified torque value.

- ⇐ Install screws for the motor evenly by hand, and then tighten them in the correct order <1, 2, 3> to 3 Nm.
- ⇐ Connect the electrical connector to the motor.
- Once installation of new motors is complete allow minimum of three (3) hours cure time of adhesive before restoring electrical power to windows. Vehicle may be moved but do not reinstall fuses until cure time is complete.
