Technical Bulletin

92 13 02 June 7, 2013 2024878 Supersedes T.B. V921204 dated November 2, 2012 to add additional model year applicability.

Wiper Blade Inspection for Proper Warranty Coding

Wiper blade inspection guidelines for wear and tear, outside influence or a factory issue.

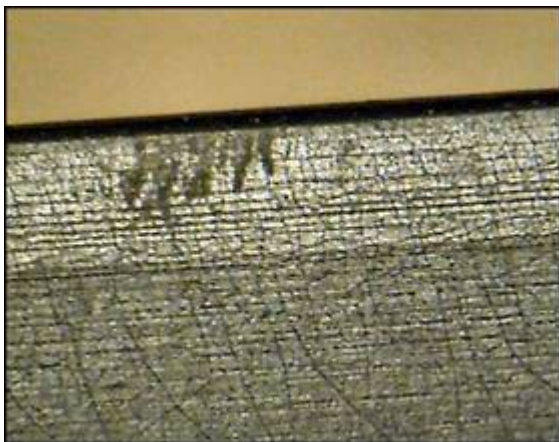
Figure 1

Worn wiper edges.

Wiper rubber insert dried out, hardened and cracked (figures 1 and 2).

Conditions in Figures 1, 2, 3 are considered wear and tear and are limited to 6 months/6,000 miles, whichever occurs first.

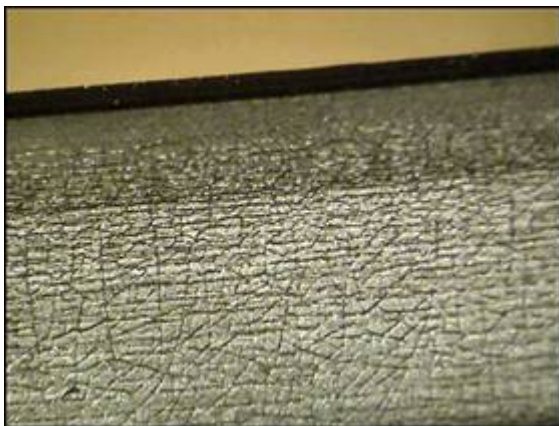
Figure 2

Wipers exposed to extreme hot or dry weather conditions can dry out and harden wipers over time.

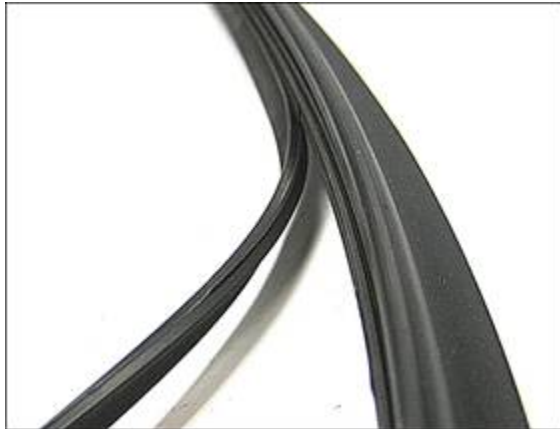
Figure 3

Wiper blade torn or insert separated.

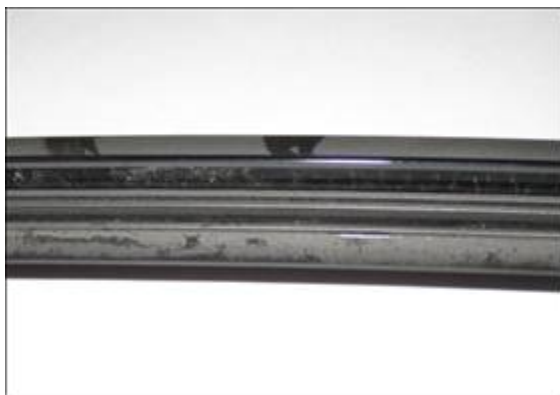
Figure 4

Contamination

Wiper blades found with contamination of tree sap, dirt and debris, wax, windshield Nano coatings, or any other substance are not covered under warranty.

Refer to technical bulletin instance [2026253 \(USA\)](#) or [2018568 \(Canada\)](#) for proper windshield inspection and cleaning before wiper blade replacement occurs.

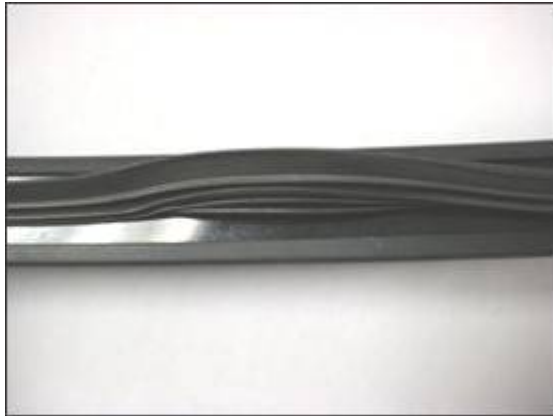
Figure 5

Wiper insert pulled from guides

Wiper insert separating from guide.

This is usually due to the wiper blade being frozen to windshield, damaged from ice scrapers, or any other object used to free wiper blade.

This is not a factory issue if not identified at time of PDI.

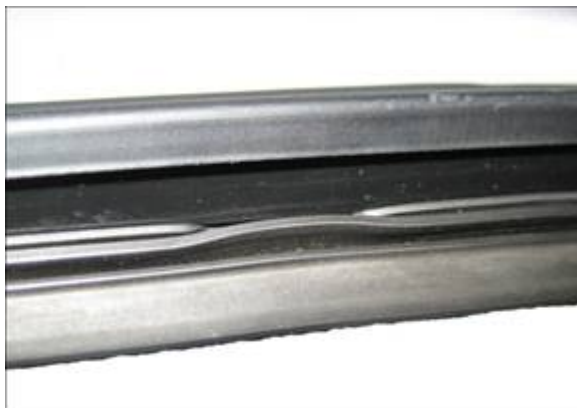
Figure 7

Wiper pinched inside guide retainers

Wiper blade is pinched between retainers during assembly.

Wiper blades should be inspected for factory issues at time of the PDI.

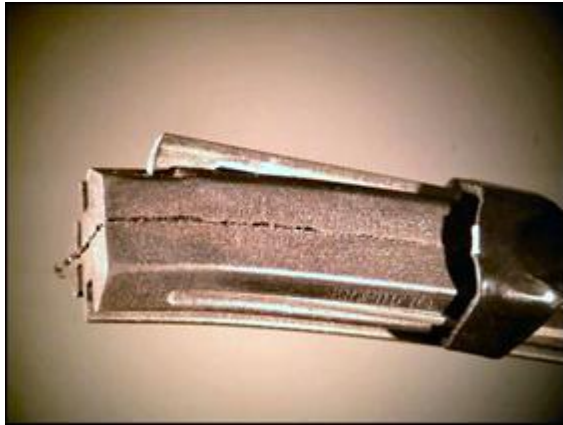
Figure 8

New Beetle / New Beetle Convertible wiper insert retainer coming out

Due to incorrect wiper arm attack angle adjustment from the factory.

Condition can only be corrected by adjusting wiper arm attack angle using Special Tool #3358B.

Refer to Elsa Web/Repair Manual/ Maintenance/ Maintenance Procedures/ Wind shield Wiper Blades, Checking End Position and Angle.
