Technical Bulletin

Model(s)	Year(s)	Eng. Code(s)	Trans. Code(s)	VIN Range From	VIN Range To
Jetta Sedan	2012	All	All	AJ_CM402958	AJ_CM474080

90 13 01 June 25, 2013 **2031344** Supersedes T. B. V901202 dated November 5, 2012 to correct TB instance number.

Instrument Cluster Clock and or Trip Buttons Inoperative

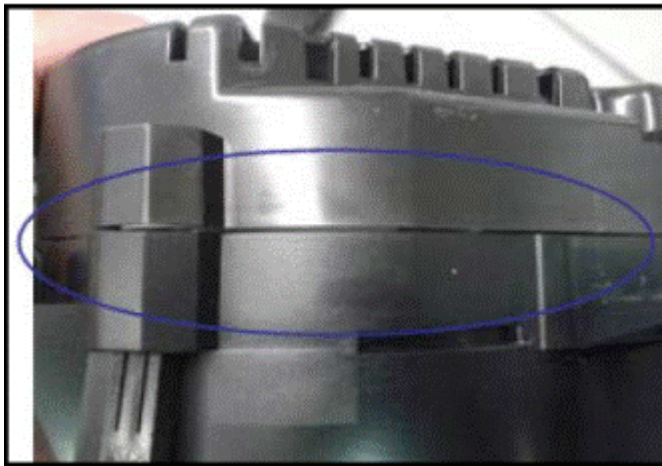
This bulletin has been released to address concerns related to clock and trip meter adjustment using the instrument cluster buttons. Because of a fitment concern between the instrument cluster halves the buttons mounted on the instrument cluster may not function properly.

Since the lower housing does not fit properly with the upper housing, the buttons do not make contact when time and/or trip meter is being set.

Improvement in the production process as of September 30th, 2012, VIN: AJ_CM474081.

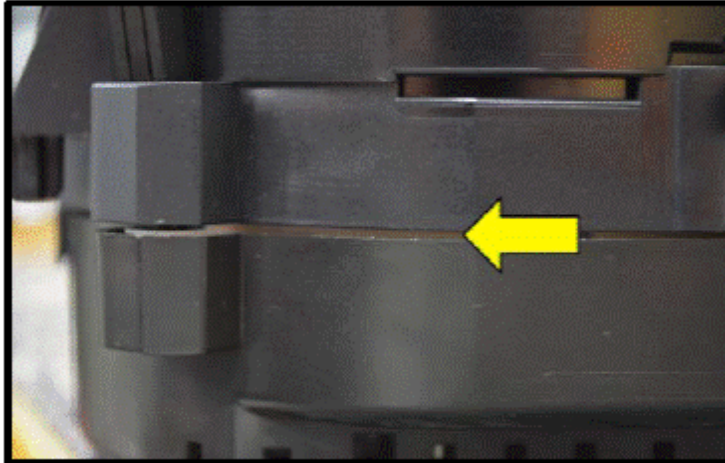
- With the instrument cluster removed from the vehicle inspect the seam between the two instrument cluster halves <arrow>.
