Technical Bulletin

40 13 02 June 25, 2013 **2028353** Supersedes V401205 dated October 15, 2012 to update coil spring part number.

Front Suspension Creaking Noise

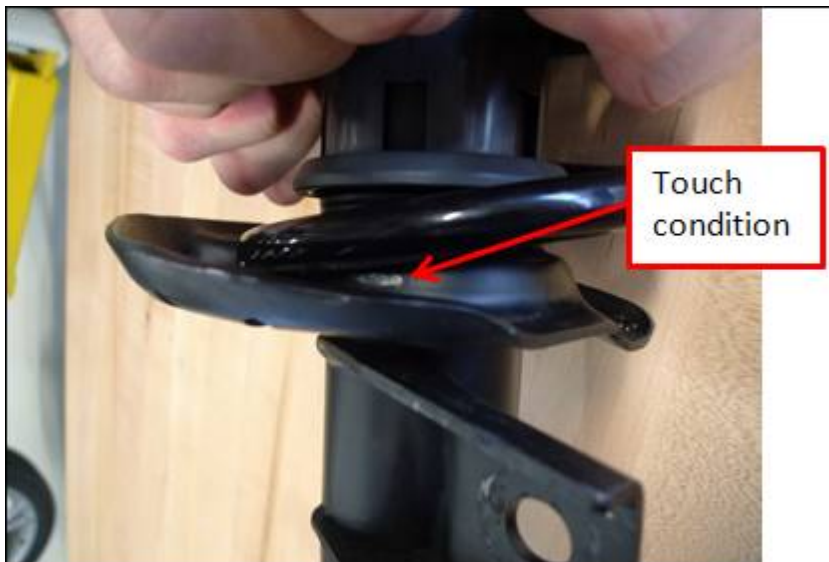
Figure 1

Front suspension creaking noise during suspension cycles (going over speed bumps or entering on an inclined surface).

Coil Spring is not formed correctly and rubs against the perch of the strut.

- Verify if a car with the creaking noise has the contact mark (on one side or on both sides) as shown in figure 1.

- Remove affected suspension strut and disassemble, see Repair Group 40 in ElsaWeb.
- Apply touch up paint to the contact area of the strut perch and allow required drying time.

Use Rustoleum Cold Galvanizing Compound # V2185838 (or similar obtained locally), 2 coats.
Cover with Rustoleum Flat Black Spray Paint # V2178838 (or similar obtained locally), 1 coat.

- Install new spring on suspension strut (per vehicle PR-codes).
- Install suspension strut, see Repair Group 40 in ElsaWeb.
