**Vehicle-specific service**Transaction No.: **2034091**

PSS RNS315 Radio\Navigation unit "Re-boots" intermittently

Release date: Jun 18, 2013

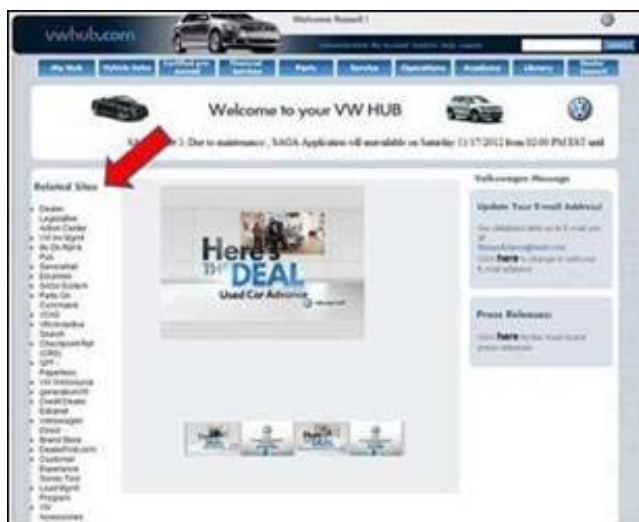
FIGURE 1. Related Sites section on VW HUB.com landing page

2. Create a PSS record in the PSS application via the hyperlink in vw hub.com (Figure 1).
