## Auxiliary A/C Inverter Case Ground VN Models

### SP396-001, Auxiliary A/C Inverter Case Ground

(December 2013)

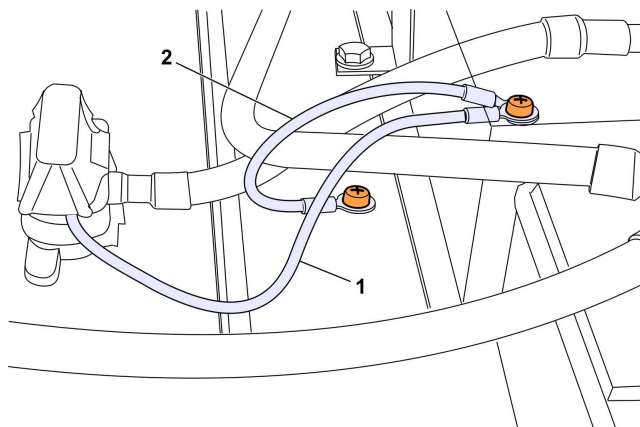
W3086000

Certain VN Product vehicles built between January 1, 2012 and May 31, 2013 with the Dometic 7 battery auxiliary AC system option requires the removal of an inverter case ground wire. Follow the procedure below to correct the issue.

- 1 Secure the vehicle for service by parking it on a flat level surface, applying the parking brake, chocking the rear wheels, and placing the transmission in neutral.
- 2 Remove battery cover.
- 3 Disconnect all cables from the negative (ground) battery terminal to prevent personal injury from electrical shock and prevent damage to electrical components.
- 4 Remove the redundant (green) wire **(2)** from the inverter case and battery box.

**Note:** Discard the wire after removal.

**Note:** Discard the ground screw on battery box.
