Date 1.2013 Group **371** No. **042** Release **02** Page 1(6)

Jumper Harness, Repair  
VN, VHD, VT, VAH

## FSB 371-042, Jumper Harness, Repair

On some Volvo trucks built between January 2010 and May 2012, the front chassis to chassis extension harness connector may not seal properly. This may lead to corrosion which can cause ABS faults. New service jumpers have been released, and should be used to replace the existing connector if corrosion occurs.

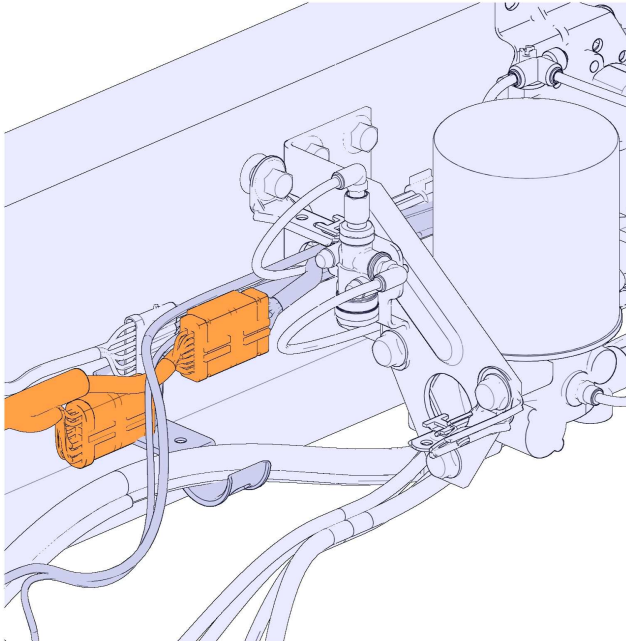
W3074254

- 3 Locate the black 14 pin connector within the frame near the air dryer as shown. There will also be a grey connector near the same area. Do not cut or splice the grey connector.

- 4 Loosen the harness section in front and behind the connector, by cutting all necessary cable ties.
- 5 Lay the harness in place over top of the old section to be removed. Mark the section to be cut just above the butt splice located from the end of the new harness. This will allow some extra length of wire to work with. Cut and remove old sections of harness.
