Diagnostic Trouble Codes (DTCs), Low Oil Pressure
 D16
 VN, VT

FSB 221-011, Diagnostic Trouble Codes (DTCs), Low Oil Pressure

(November 2013)

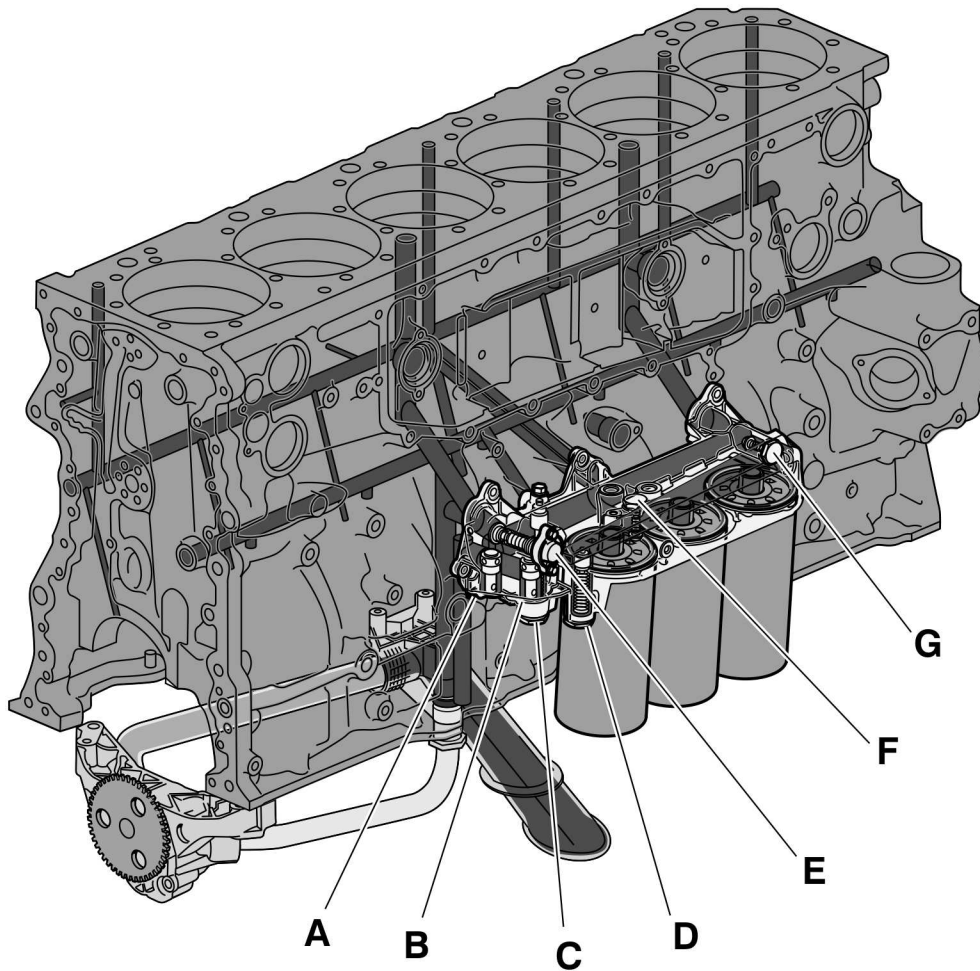
T2023373

During long hard pull conditions, diagnostic trouble codes (DTCs) PID 100 FM1, SPN 100 FMI 1 or P252400 can log on certain VOLVO vehicles with D16 engines built from January 2007 to current production. If any of these DTCs occurs during the conditions described in this bulletin, with or without an engine shut down lamp, follow Guided Diagnostics for fault tracing.

A	Pressure Reduction (Relief) Valve, Purple
B	Regulating Valve
C	Control Valve for piston cooling
D	Opening Valve for piston cooling
E	Overflow Valve for oil cooler
F	Overflow Valve for the bypass filter
G	By-pass Valve for full-flow filter

Follow Guided Diagnostics fault tracing and verify the oil pressure readings with a manual gauge at various engine revolutions per minute (RPM). After verifying all checks are within specification, if the issue is still present and there are no obvious signs of oil dilution, replace the pressure reduction (relief) valve (purple) using the procedure below.
