**Battery Cable Lug, Failure**  
**VN, VHD**

## FSB 371-045, Battery Cable Lug, Failure

(July 2013)

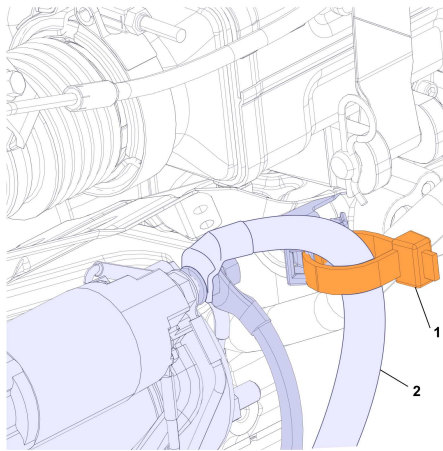
W2080364

Certain vehicles built from January 1, 2010 to June 14, 2013 with a D11 engines may experience cracking or breaking of the 90 degree positive battery cable lug at the starter solenoid stud. In some cases, the lug is bent during assembly, and along with engine vibration may cause the terminal to weaken and fail over time.

- 6 Install the cable tie around the saddle and positive battery cable going to the starter solenoid.

- 1. Cable Tie
- 2. Positive Battery Cable

**Note:** Battery cable may need to be loosened/retightened from back of starter solenoid in order to reach the saddle. Tighten to  $26 \pm 1.5$  Nm ( $19.2 \pm 1.1$  ft lb).
