NUMBER: 18-011-13

Flash: MIL Illumination P050B and/or Rattle/Clatter Sound on Cold Start-up

2011 - 2013 MK

Compass/Patriot

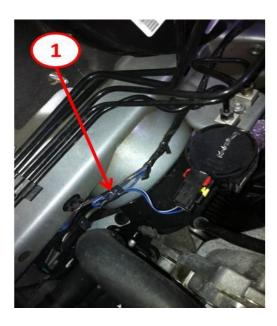
Fig. 2 urge Solenoid Wire Harness Routing

1 - Secured Purge Wire Harness

13. Loosely pull the purge solenoid wire harness straight and create a bend in the harness approximately 10mm (0.40 in. or 3/8 - 7/16 in.) away from the harness retaining clip edge. This bend will also create a natural bend after the current spot tape on the harness. Then, apply 3 - 4 wraps of electrical tape securing the bend to the harness as shown in (Fig. 2).
