**NUMBER:** 02-001-13

**GROUP:** Front Suspension

Noise From Front Of Vehicle Over Bumps Or When Turning

2012-2013 (JC) Journey

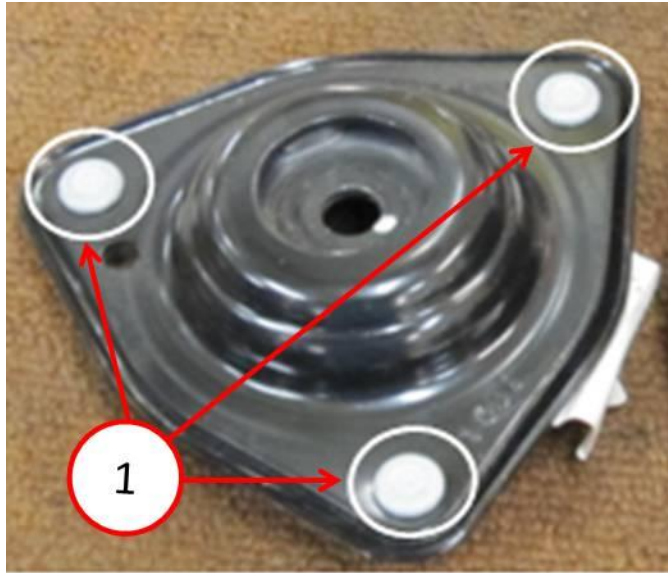
***Fig. 1 Front upper Strut Bracket***

1 - Stud Heads

**NOTE:** Assemble the upper front mount strut bracket (**Fig. 1**) to the upper front strut bearing (**Fig. 2**) by aligning the stud heads on the strut bracket to the 3 notches on the strut bearing.

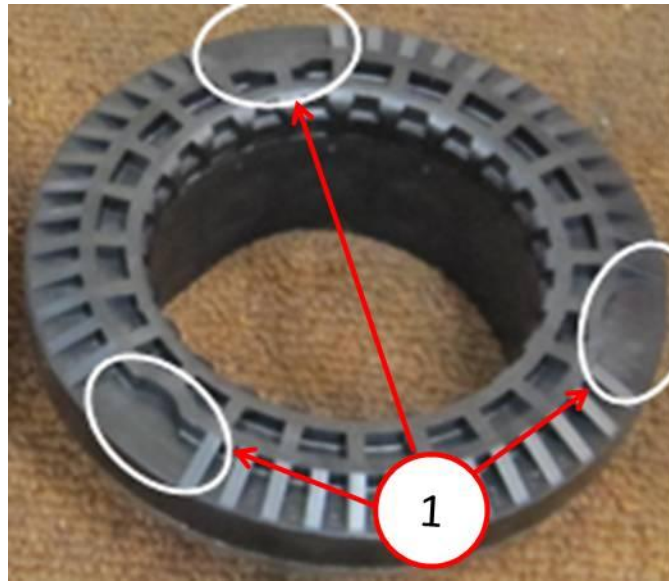
**Fig. 2 Front Upper Strut Bearing**

1 - Notches
