Bulletin No.: PI0531B

Service Bulletin

Subject: Transmission Over Temperature, Malfunction Indicator Lamp (MIL) Illuminated, DTC U0101 Set (Inspect Transmission Cooler Lines)

Models: 2011-2013 Chevrolet Silverado
2011-2013 GMC Sierra
Equipped with 6L90 (RPO MYD) Automatic Transmission

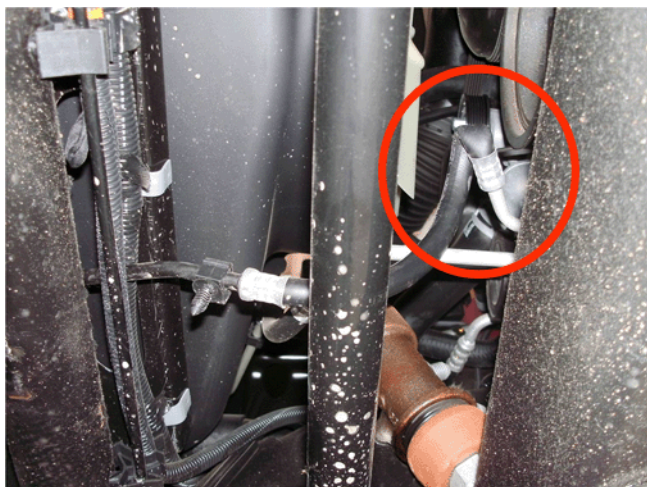
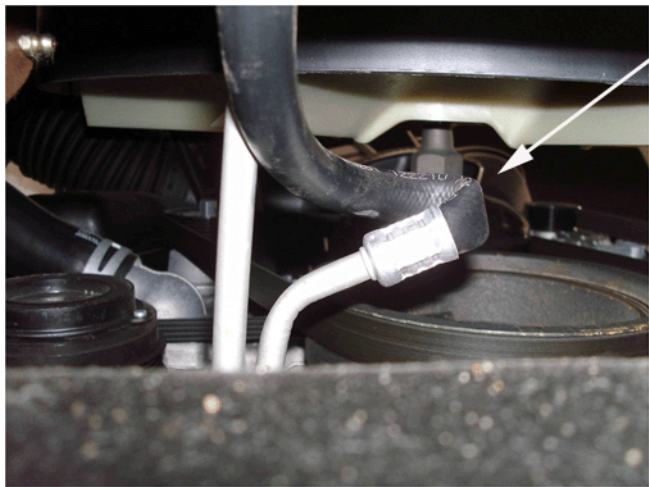
This condition may be caused by twisted or kinked transmission oil cooler lines. Inspect the transmission oil cooler lines near the radiator for any twists or kinks. Correct as required.

If twisted or kinked cooler lines are found, the transmission fluid level and condition should be checked for signs of distressed fluid. Remove the transmission fluid pan assembly to inspect for signs of internal distress.
