# Service Bulletin

**Subject:** Rattle/Squeak Noise and/or Rear of Center Console Loose

**Models:** 2013 Cadillac ATS  
Vehicles Built Prior to May 10, 2013

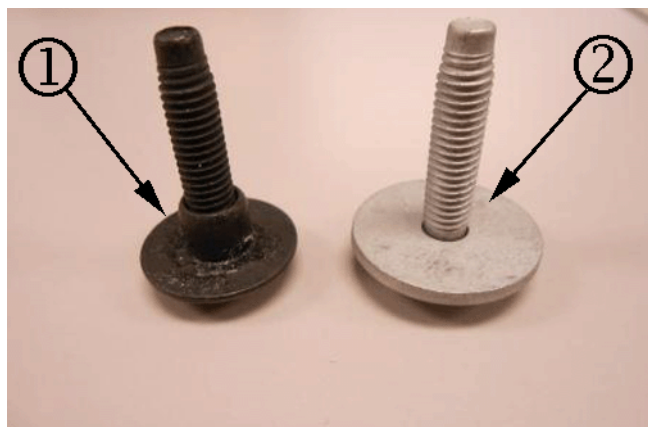
This may be due to a design change with the rear of the center console that may cause the two rear attaching bolts to bottom out before being fully secured.

**Note:** (1) is the bolt used during production, (2) is the revised bolt being used
