Service Bulletin

Subject: Excessive Oil Consumption – Perform Oil Consumption Test and/or Install Piston and Piston Ring Kit

Models: 2010-2013 Buick LaCrosse
2011-2013 Buick Regal
2010-2013 Chevrolet Equinox
2010-2013 GMC Terrain
Equipped with 2.4L Engine (RPOs LAF, LEA)

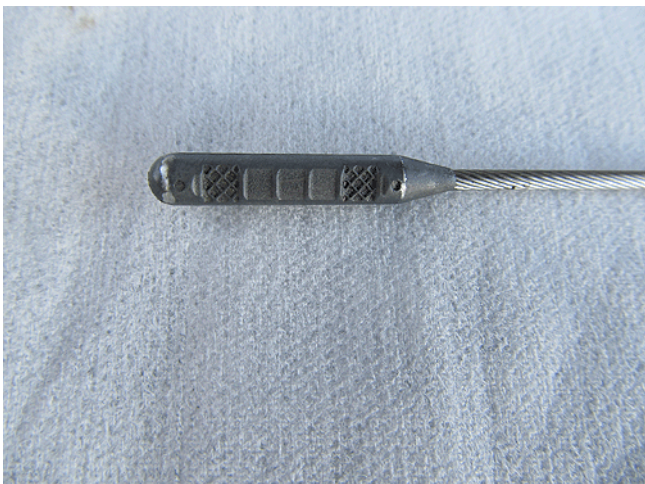
Important: When checking the oil level with the oil dipstick design shown below, please note that the oil volume per notch is not linear due to the shape of the block. The upper notches (relative to the top of the handle) equal 0.24 quart (0.227 L) between each notch while the lower notches only equal 0.14 quart (0.132 L) between each notch. As a result, no oil will appear on the dipstick if it is low on oil by approximately 1.25quarts (1.18 L) or more. When determining the oil consumption rate, the oil volume added to return it to the starting location is the total amount of oil consumed. The consumption rate must be documented on a repair order.

Notice: Do not add too much oil. An overfill can lead to burn off of the excess oil. Advise the customer to wait until the oil is below the cross-hatched area at the tip of the dipstick before adding oil.

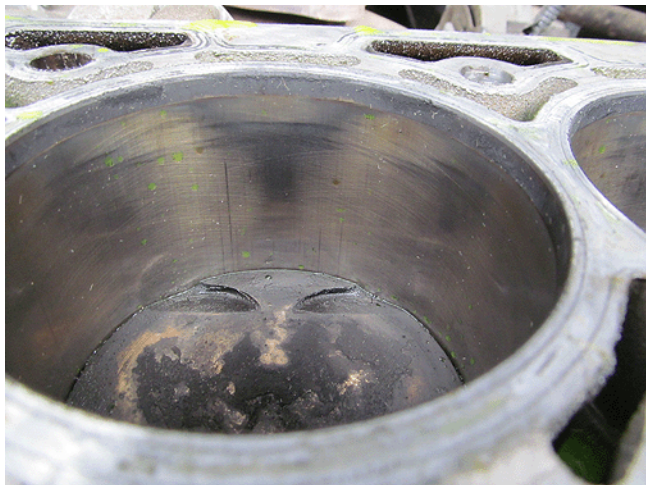
The repair is to replace the pistons and rings. In some cases the bore surface may not have a uniform look to the finish (zebra stripes) as shown below. As a result, some technicians may question whether the engine should be repaired or replaced. After careful evaluation, GM Powertrain has determined that the new pistons and rings will perform correctly in bores that have this appearance so engine replacement should not be necessary. The cylinder bores do not need any machine or honing work performed on them. Refer to the picture below for acceptable surface finishes.

Acceptable Cylinder that Does Not Appear Uniform (Zebra Stripes)

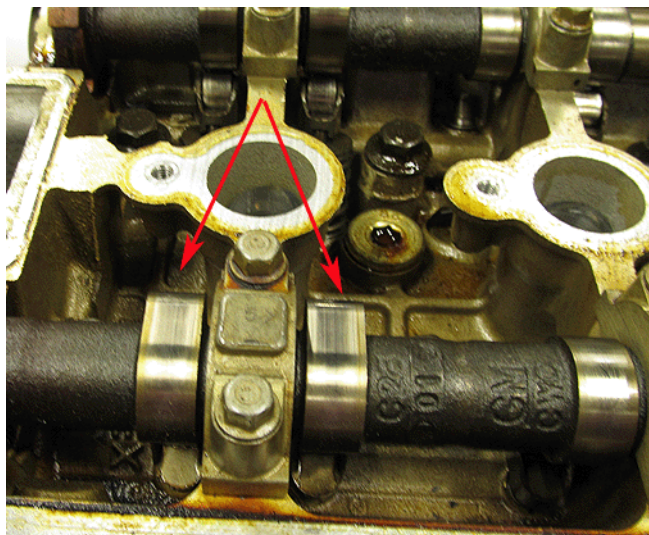
- Camshafts and roller follower will have wear markings. This is normal and do not need to be replaced (refer to picture above).

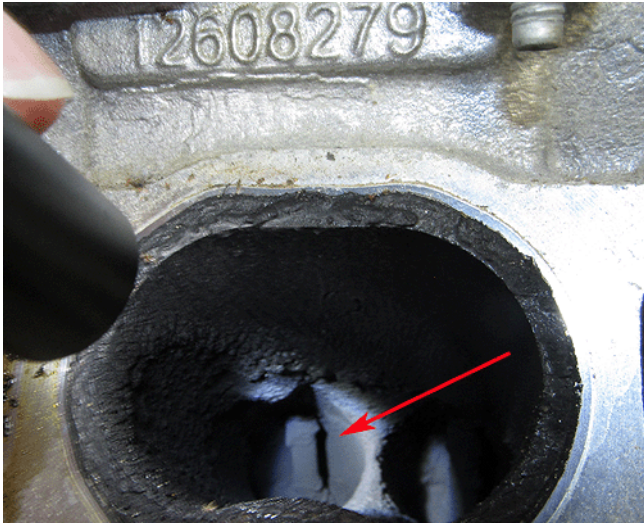
- Valves stems may have deposits build up on them. These deposits are characteristic of a direct inject engine. The valves stems do not need to be cleaned as they are not affecting engine performance (Refer to picture above).
- The oil pump does not need to be replaced as the low oil level operation did not damage the pump.
- The camshaft actuators do not need to be replaced at this time. The vehicle may have arrived with the engine knocking. If the oil level was 1 1/2 - 2 quarts low, it was the lack of oil causing the actuator noise.
- Rod bearings can be reused if there is not any excessive scoring, some light wear marks are acceptable
