Service Bulletin

Bulletin No.: Pl0907A

Subject: Check Engine Light On with DTC P1101 Set

Models: 2013 Buick Encore

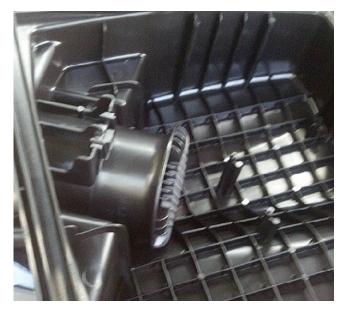
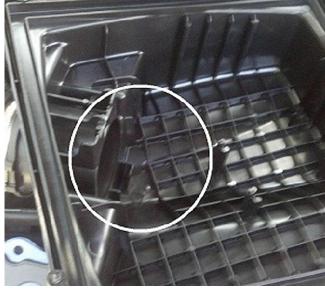
A missing or mispositioned air baffle in the air cleaner box could cause the TPS readings to be low and the vehicle setting P1101. Verify the air baffle is in the proper place before continuing with diagnostics. Refer to the pictures below.
