Service Bulletin

PRELIMINARY INFORMATION

Subject: Left Front Fender Liner Rattle, Ticking or Flutter Noise While Driving

Models: 2012-2013 Chevrolet Impala

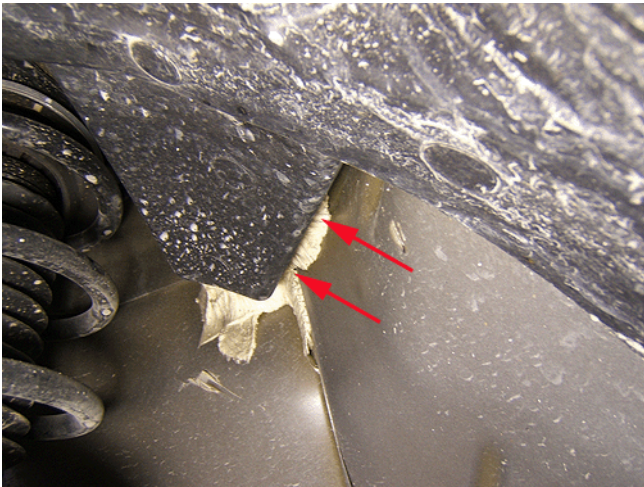
Some customers may comment on a noise coming from the left front of the vehicle while driving at speeds above 65 km/h (40 mph). This condition may be described as a rattle, flutter or ticking type noise.

This noise may be caused by the left front plastic fender liner (splash shield) making contact with the body structure.

Use the following steps to install isolating material on the fender liner that will prevent hard contact between the two components.
