Service Bulletin

Subject: Sloshing or Clunking Noise From Rear Compartment When Turning, During Lane Changes, Harsh Braking or Traveling Over Bumps in Road

Models: 2014 Chevrolet Cruze
Equipped With 4 Cylinder Diesel Engine RPO LUZ

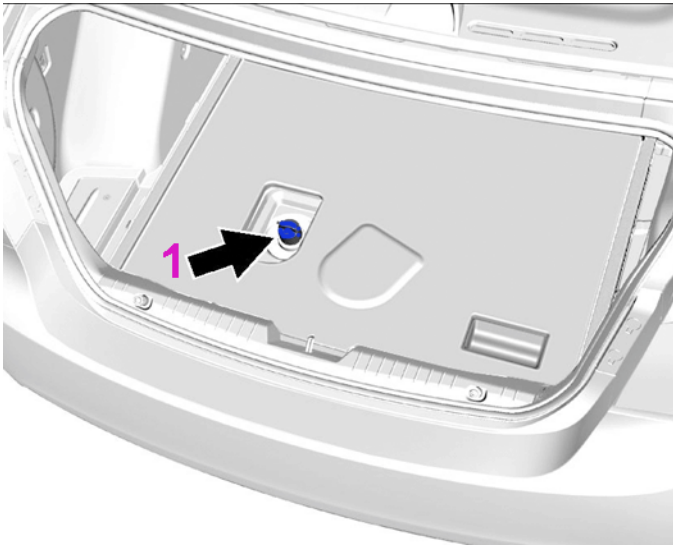
This condition may be caused by the diesel exhaust fluid (DEF) also known as emission reduction fluid sloshing around in the DEF tank, which is located under the load floor carpet in the trunk. This noise may become more noticeable as the level of the DEF fluid in the tank decreases.

To fill the DEF tank, raise the load floor carpet in the trunk and remove the blue filler cap (1) on the tank. Add DEF as needed. Do not overfill the tank.
