Bulletin No.: PI0957

# Service Bulletin

**Subject:** Diagnostic Tips for Front Cover Oil Leak

**Models:** 2013 Buick Encore  
2011–2013 Chevrolet Cruze  
2012–2013 Chevrolet Sonic  
2013 Chevrolet Trax  
Equipped with 1.4L Engine (RPO LUJ or LUV)

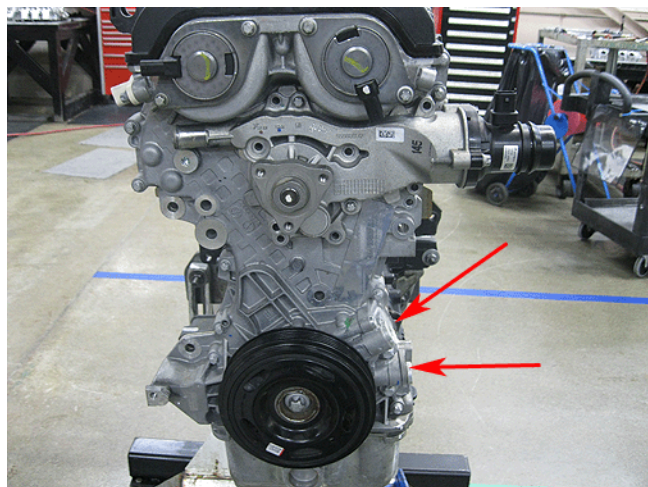
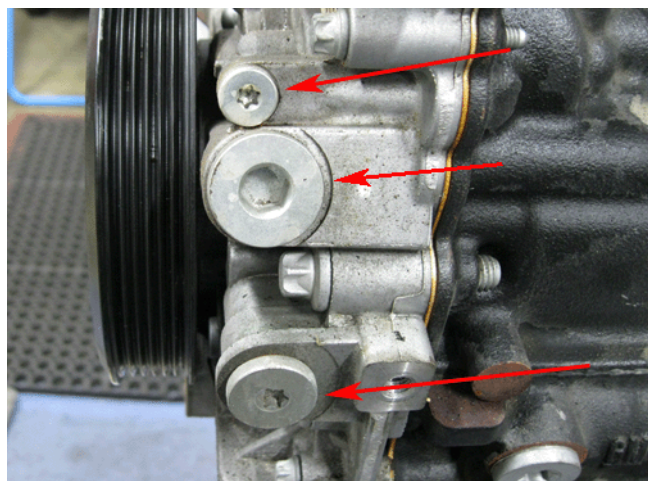
Possible front cover leak locations are the 90 degree and 45 degree plugs located on the front cover next to the A/C compressor. These could be misdiagnosed as an oil pan seal or front balancer seal leak. It is very important to use an engine oil dye to help accurately locate the oil leak.

If these plugs are determined to leak, technicians may find an indentation in the copper seal due to debris. You should look at the plug and front cover for any debris that could cause a repeat leak if not removed. Refer to the pictures above for the location of the plugs. Replace the front cover seal and/or the plug(s) as necessary.
