# Service Bulletin

**Subject:** Hydraulic Pump Leaking Fluid in Area of Rear Seat, Floor or Trunk, Convertible Top Inoperative or Noise

**Models:** 2011-2014 Camaro Convertible

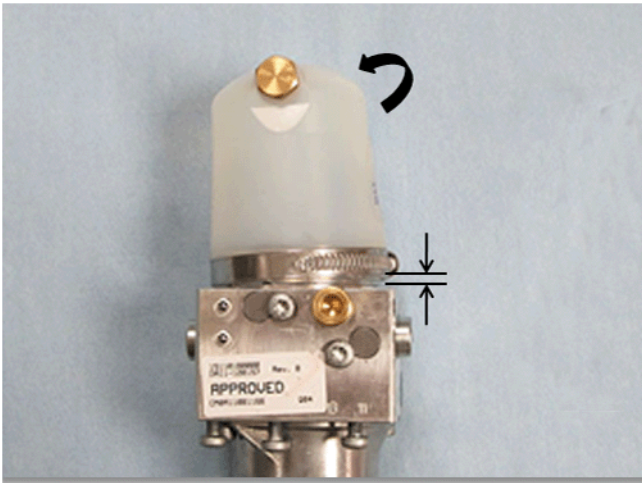
The cause of this condition may be that the fluid reservoir on the pump was either improperly installed at the supplier or knocked out of position during installation to the vehicle and is leaking oil.

2. Inspect the fluid reservoir for correct installation/position on the pump assembly. The graphic above shows an example of the reservoir tipped and not properly seated, which exposes a gap where fluid can leak.

3. Loosen the retaining clamp screw and fully seat the reservoir to the pump. Re-tighten the clamp screw.

**Tighten:** Tighten the screw to 4 Y (35 lb in).

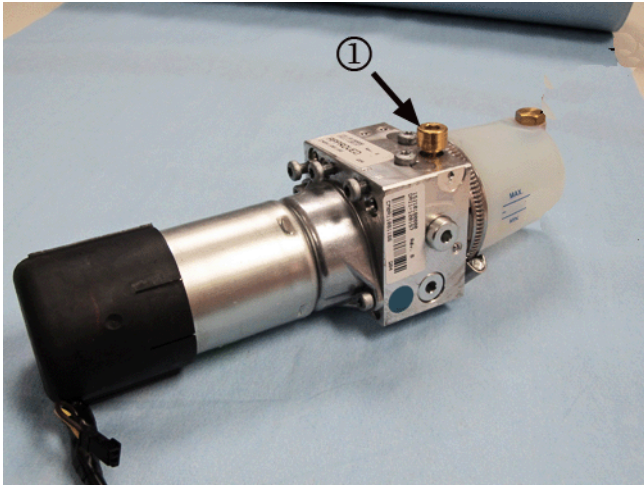
**Important:** When checking for fluid leaks, pay close attention to the manual release valve (1). A maximum of one and a half revolutions is recommended when opening this release valve. If for any reason the valve was turned out more than one and a half revolutions, the potential for damaging the valve seal could exist. This valve seal is NOT serviceable, so once the release valve is fully closed, if any fluid leak is evident at the valve location, the folding top pump assembly would have to be replaced.

**Note:** Recommended torque specifications for the reservoir fill plug is 2 Y (18 lb in) and for the manual release valve is 4 Y (35 lb in).
