Authorized Field Change

AFC 13903

Subject: Inspection of Air Control Valve (ACV) Connector / Engine Harness Connection for proper plug orientation and corrosion.

Model: LoneStar®, PayStar®, ProStar®, TranStar®, and WorkStar®
Start Date: 03 April 2012 End Date: 31 May 2012

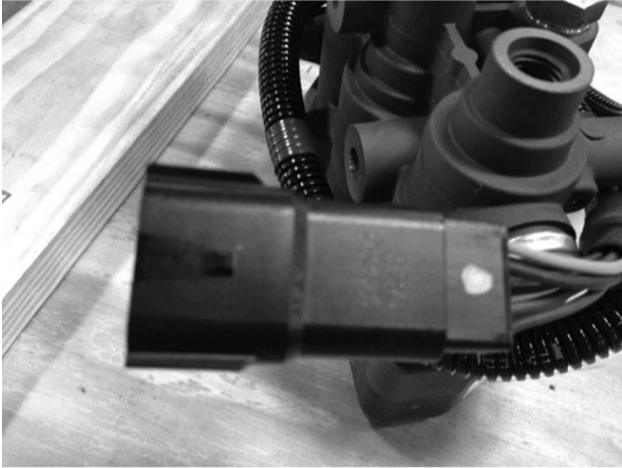
Figure 3. Marked ACV Connector.

5. Inspect base of connector for presence of yellow paint dot (Figure 3).
 - a. If yellow paint dot is present, proceed to Step 54.
 - b. If no yellow paint dot is present, proceed to Step 6.

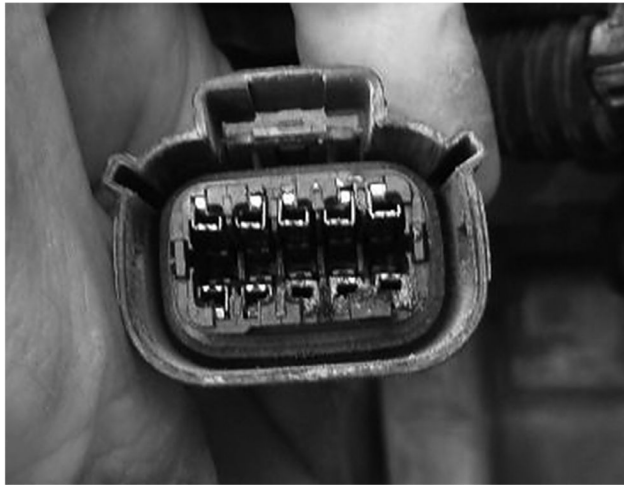
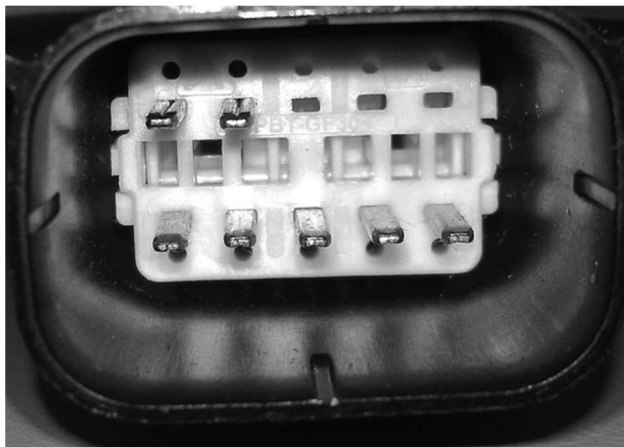
8. Inspect both sides of connector for corrosion (Figures 4 and 5).
 - a. If corrosion is present, proceed to Step 20 and finish labor operation A40-13903-3, install new ACV kit and higher level ACV kit.
 - b. If no corrosion is present, proceed to Step 9 and finish labor operation A40-13903-2, reverse cavity plugs.

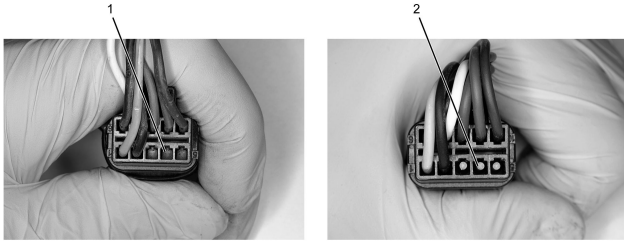
Figure 6. ACV Connector Plugs.

1. Incorrectly installed plugs
2. Correctly installed plugs

NOTE: Incorrectly installed plugs may cause corrosion due to moisture intrusion.

9. Inspect plugs in ACV connector to determine if they have been inserted backwards (Figure 6).
 - a. If plugs are installed correctly (Figure 6, Item 2), reconnect mating ends of connector, re-latch red lock button, and proceed to Step 52.
 - b. If installed incorrectly (Figure 6, Item 1), proceed to Step 10.
