Document ID: IK0100033
Revision: 0
Created: 10/8/2013
Last Modified: 10/11/2013
Author: Nicholas Pilotte

Title: Frame Damage Due To Improper Engine Oil Pressure Testing Location

Applies To: All EPA 2010 and new 11/13L engines

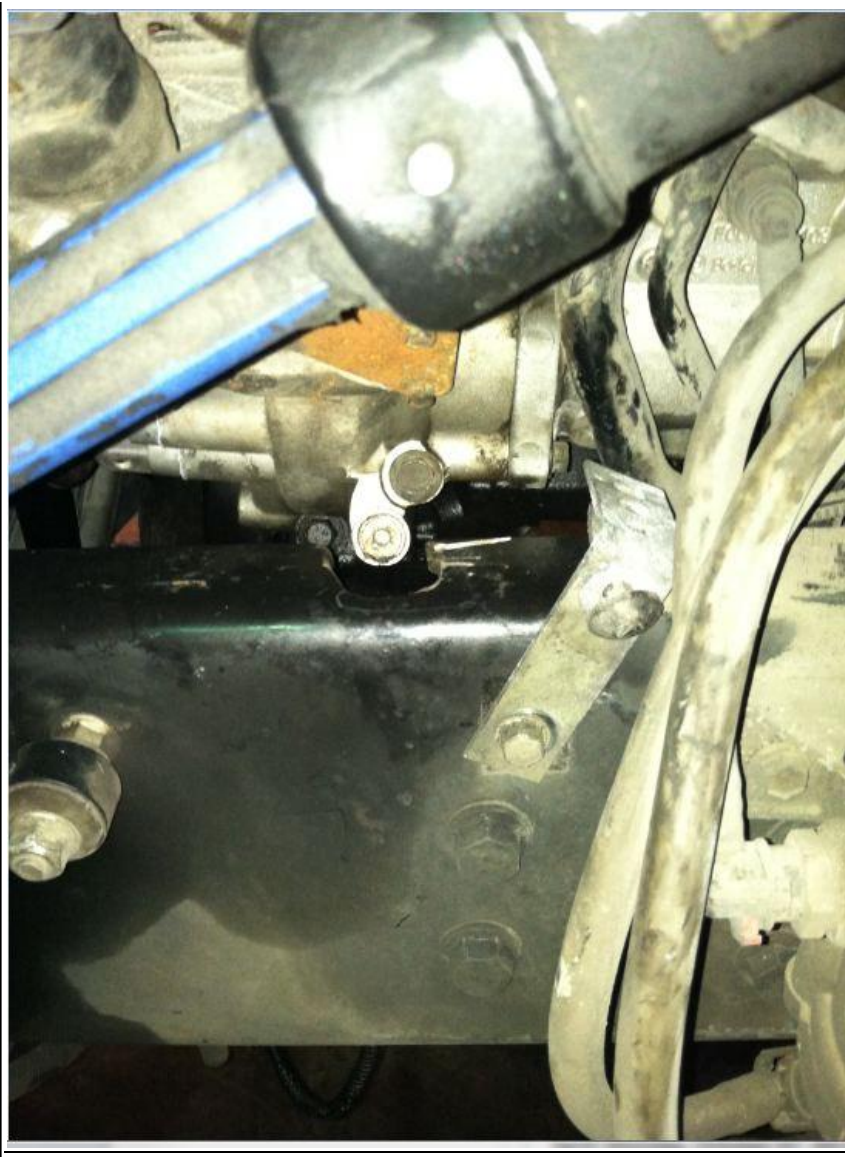
It has been found some dealers are checking engine oil pressure with a manual gauge incorrectly on 2010 11/13L engines. They are checking oil pressure on the front gear cover in the place where the 2007 engines are checked. In order to gain access to this fitting on the 2010 engine, dealers are notching frame rails to do this. The practice of cutting a frame flange is dangerous and causes serious integrity issues with the frame rail. This is never to be done. The proper procedure is specified in the 2010 MaxxFORCE 11 and 13 Engine Diagnostic Manual. Engine oil pressure must be checked at the EOP sensor port. If you have trouble finding a fitting locally for this test, please see iKnow article IK1200372.

Contact Chassis Technical Support for further repair direction if you find a frame rail modified like this.
