**Countries:** CANADA, UNITED STATES, MEXICO **Document ID:** IK0800284  
**Availability:** ISIS, FleetSIS **Revision:** 3  
**Major System:** ELECTRICAL SYSTEM **Created:** 5/16/2011  
**Current Language:** English **Last Modified:** 10/15/2013  
**Other Languages:** [Français](#), [Español](#), **Author:** Will (Mark) Wiley  
**Viewed:** 1807

**Title:** Ambient Air Temperature (AAT) sensor faults

**Applies To:** 2010 EPA MaxxForce® 11 and 13 ProStar® and WorkStar®

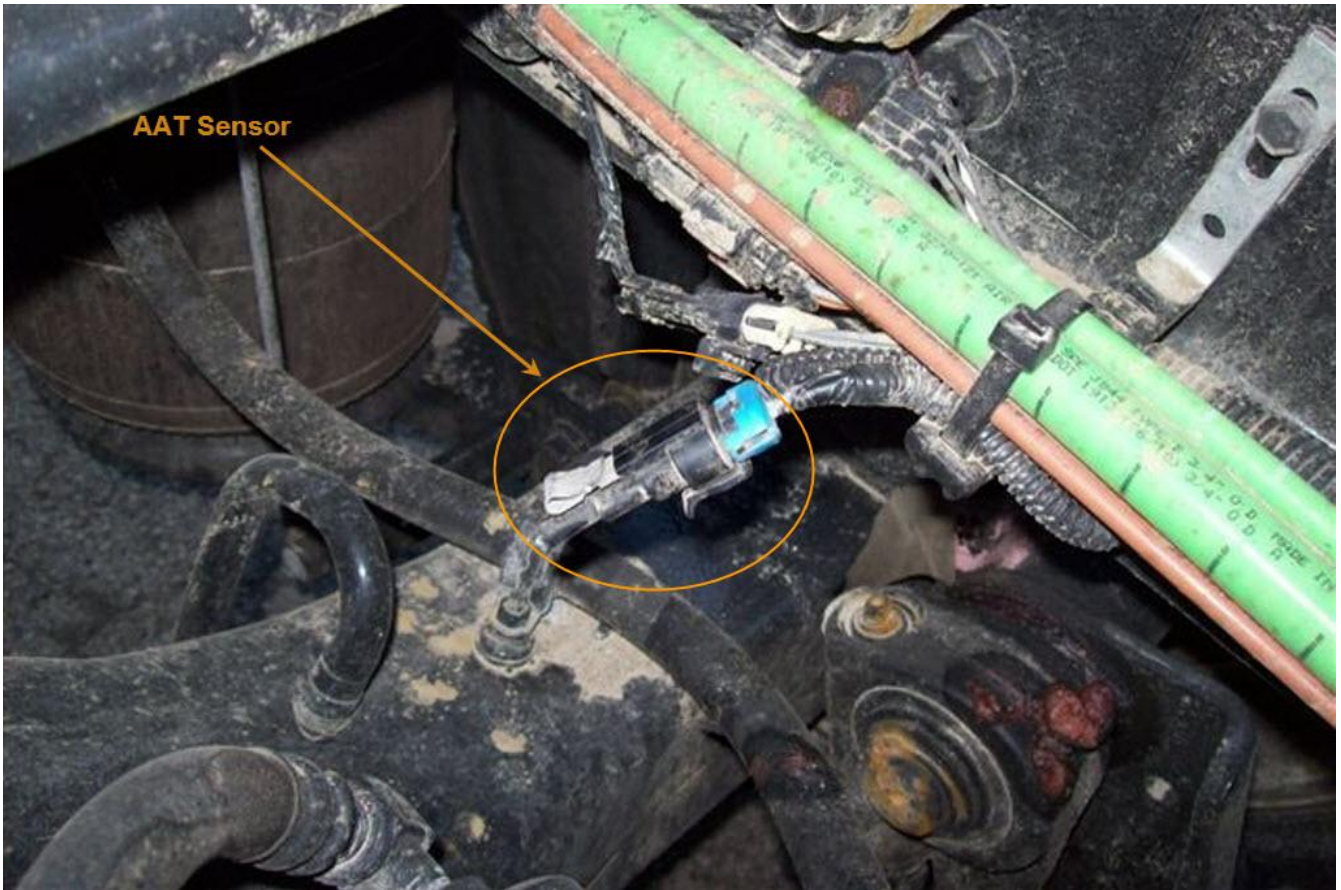
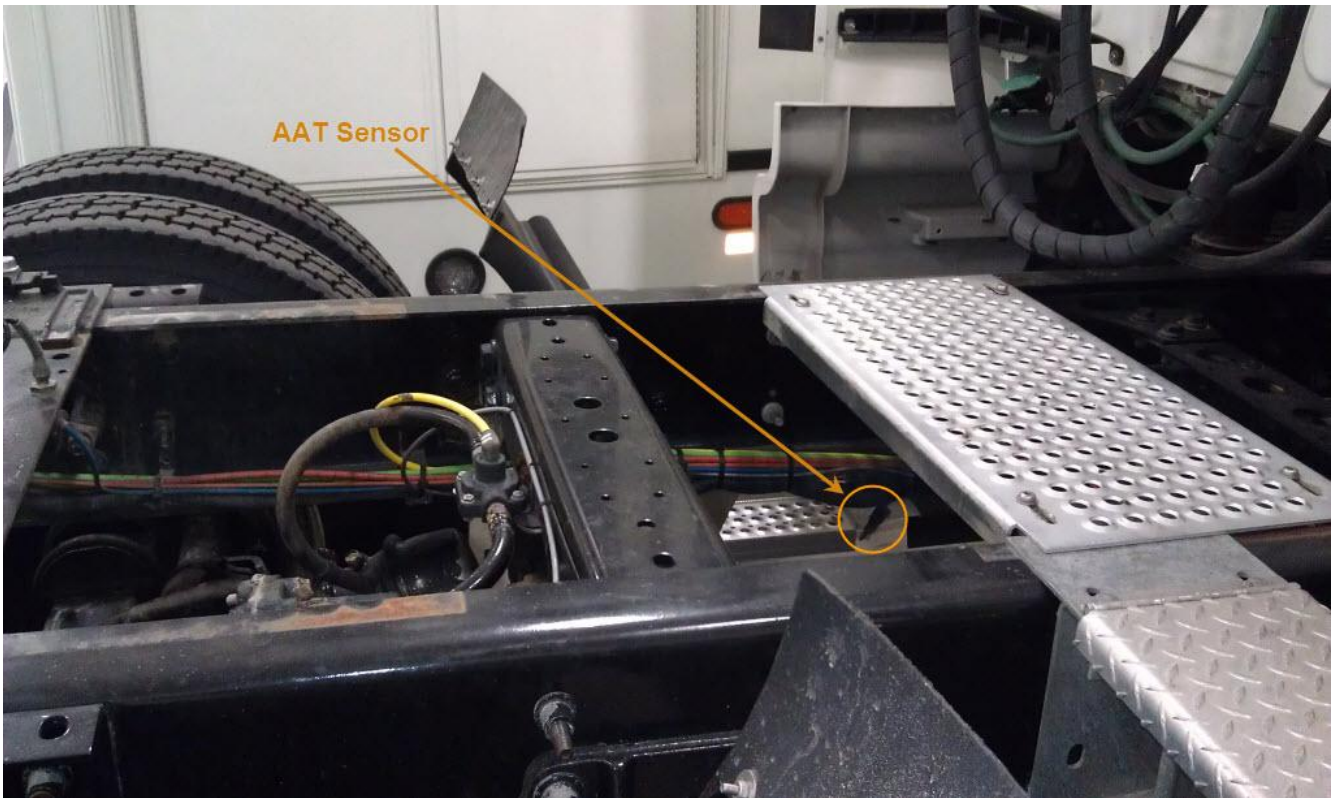
The *Engine* sensor is located on the left frame rail midway between the back of cab and front drive axle, or near the front drive axle. The two photos below show both possible mounting locations.
