CANADA, UNITED STATES, MEXICO Document ID: IK0900075 Countries: Availability: 1212 Revision: Major System: COOLING Created: 11/19/2012 Last Modified: 10/16/2013 Current Language: English Other Languages: NONE Author: Thomas Hoffmeister

Title: Horton Stratis Fan Hub Diagnostics

Applies To: Prostar, LoneStar, TranStar, WorkStar, IBB

Horton VMaster Ultra (Stratis) Viscous Fan Drive Troubleshooting Guide Engine feature code 12THX

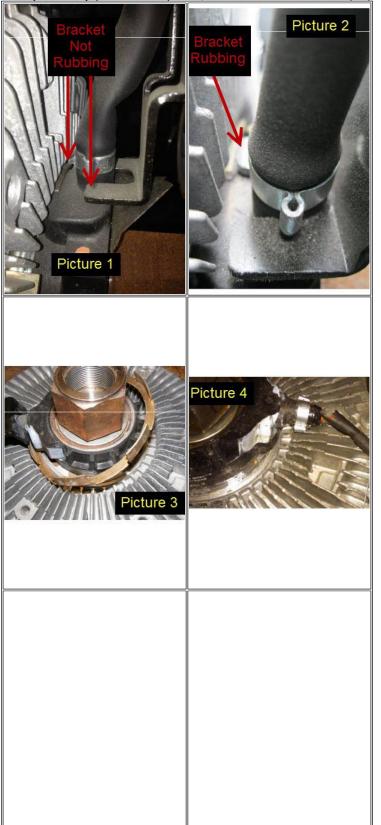
- If multiple wires are showing copper, remove and replace the fan hub assembly.
 Reroute the wiring harness at outlined in the "Harness Re-Route Procedure" in this iKNow article.
- o Check to see if ARB is touching the target wheel. Refer to Picture 1 and Picture 2.

- If it is touching, reposition ARB to clear the target wheel as shown in Picture 1.
 Check to see if the target wheel is loose, moves, or spins freely.
 If it is loose, moves, or spins freely replace the fan hub assembly.
 An improperly positioned ARB or loose target wheel can cause the damage in Picture 4.
 Pull / Push on fan refer to Picture 5.
 Rotating the fan by hand, the hub should provide a smooth and consistent resistance.
 If it rotates freely approximately 1" or more before resistance is felt, replace the fan hub assembly.
 If you have any questions on this process, call Horton customer service at 1 (800) 621-1320 for assistance.

- If rubbing is present and inside wires are visible, but no copper is visible apply heat shrink over the harness.
- If copper can be seen, check to see if it is only one single wire, or multiple wires.
 - If it is one wire, place electrical tape over the wire.
 - Using 4:1 heat shrink will allow the heat shrink tubing to pass over the connector as shown. P/N: ZBJE849565 or equivalent

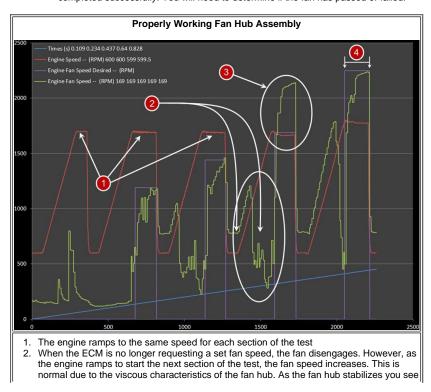
- the fan speed then continues to decrease.
- This section of the test shows the fan speed higher than the desired fan speed. This is due to engine speed and desired speed being very similar values. The fan is then commanded ON, and the fan speed is 125% of desired. This is normal.
- This is showing the duration of the fan on command. Notice in each section the fan does
 not match up and perfectly align. This is due to the PWM (Pulse Width Modulated) signal
 that is being sent to the fan hub.
 - You can review your fan test in ServiceMaxx to see a chart view of the signals shown in this chart.
 - If you have any questions of the results, attach your fan test snapshot to your case file for review.

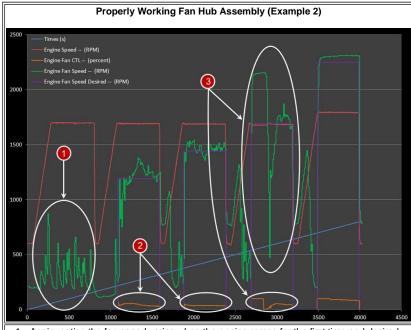
- Again, notice the fan speed varies when the engine ramps for the first time and desired fan speed is zero. This is normal due to the viscous properties of the fan hub, and is normal operation.
- 2. The Fan Control % has been added to this chart.
- 3. As stated in the chart above, due to the engine speed and desired fan speed being very similar values, the ECM commands the fan on at 98.04%. However, in this test the ECM tries to change the fan speed by changing the fan control percent. The fan control percent drops near zero to attempt to achieve this. While this is a different reaction for this portion of the test then the chart above, it is still normal operation.
 - You can review your fan test in ServiceMaxx to see a chart view of the signals shown in this chart.
 - $\circ\,$ If you have any questions of the results, attach your fan test snapshot to your case file for review.

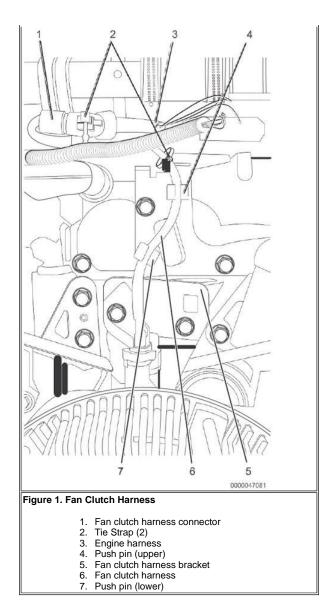
- Remove two tie straps (Figure 1, Item 2) securing fan clutch harness (Figure 1, Item 6) to engine harness (Figure 1, Item 3) and fan clutch harness bracket (Figure 1, Item 5). Discard tie straps.
 Remove harness from upper and lower push pins (Figure 1, Items 4 and 7).

Inspect fan clutch harness (Figure 1, Item 6a) for signs of wear from contact with sharp or hard surfaces of harness bracket (Figure 1, Item 5).

a. If no damage is observed, proceed to Step 16.
 b. If insulation chafing is observed or if copper is exposed or damaged, proceed to Step 8.
