**Document ID:** IK1200163

**Title: Updated I6 EVRT/VGT Diagnostics Check Sheet and Turbocharger Repair Procedures for engines that exhibit DTC 353 / 354**

**Applies To: 2004- 2006 MY EGR DT 466 and 570 with EVRT/VGT Turbos with ESN 2,000,001 - ESN 3,000,000**

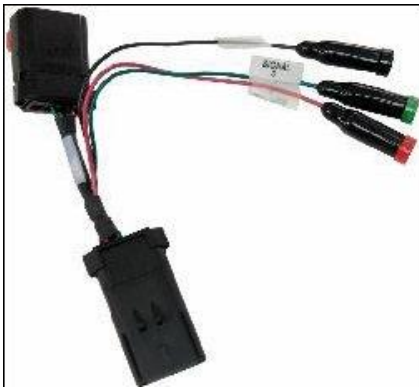
1. Connect the turbocharger breakout harness between the engine harness and the turbocharger actuator pigtail.

Note: The male/female connector has an additional retention locking feature that must be disengaged prior to separating the male/female connectors. This slide locking tab may be coated with paint that will be required to be scrapped off to ease disassembly.

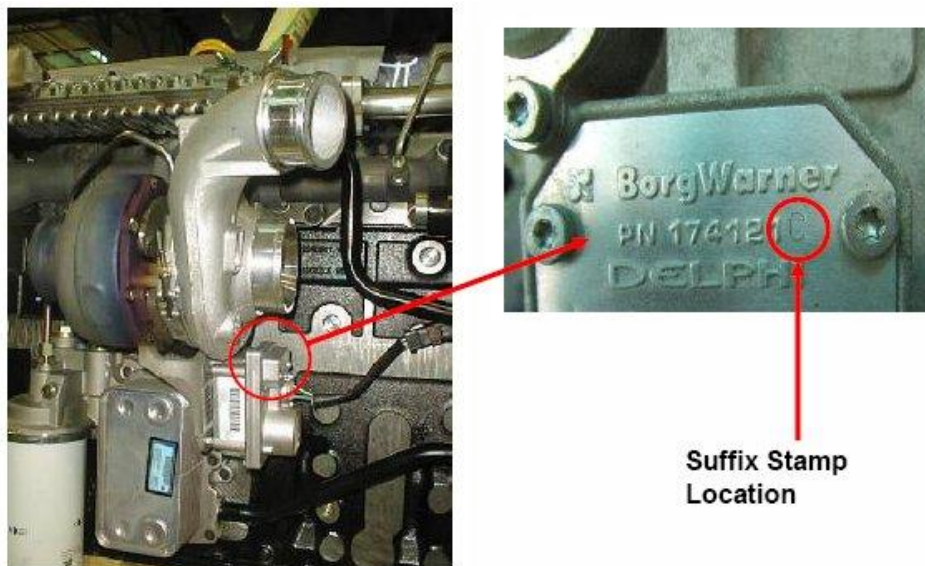
1. Locate the name plate stamp located on the actuator body.

2. Locate and identify the Suffix Stamp next to the Borg Warner Actuator Part Number embossed on the name plate. The Suffix Stamp will be a letter designation, but also maybe blank and not have a Suffix stamp letter.

**Decision Step 4A:** If it does not have Suffix stamp next to the part number, replace the actuator with Actuator Service Kit P/N 1847620C91.

**Decision Step 4B:** If the Suffix stamp next to the part number is A, B, C or D, replace the actuator with Actuator Service Kit P/N 1847620C91.

**Decision Step 4C:** If the Suffix stamp next to the part number is E, go to Step 5 Check the EBP Sensor Part Number.

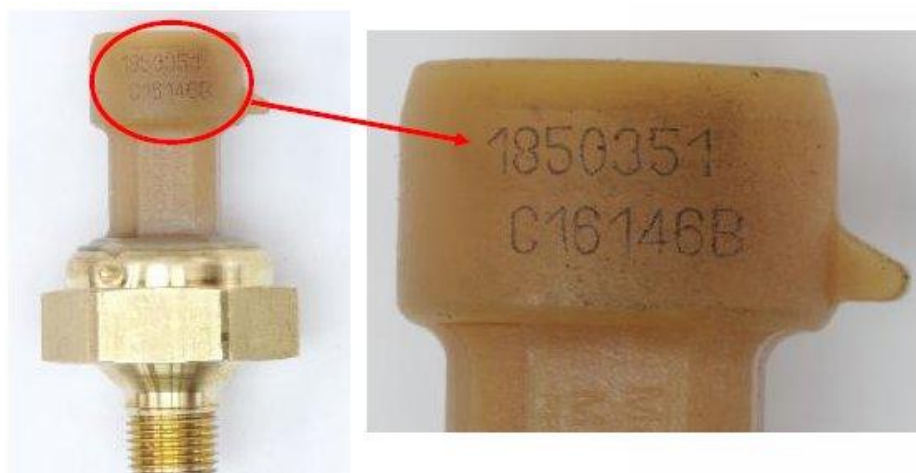
1. Locate the Exhaust Backpressure Sensor (EBP) located at the right front corner of the engine just above the alternator.
2. Locate and check the EBP part number printed on the plastic portion of the sensor body.

The printed part number will appear on 2 lines of the sensor body. The seven digit part number will be on the first line, and the second line will start with the part number suffix (ex. C1).

**Decision Step 5A:** If the EBP Sensor is not part number 1850351C1, replace the sensor.

**Decision Step 5B:** If the EBP Sensor is part number 1850351C1, The sensor does not need replaced unless you suspect EBP sensor is out of range. perform the EBP diagnostics steps in the Engine Diagnostic Manual [EGES 270-1 EBP Sensor](#) to validate the EBP sensor.

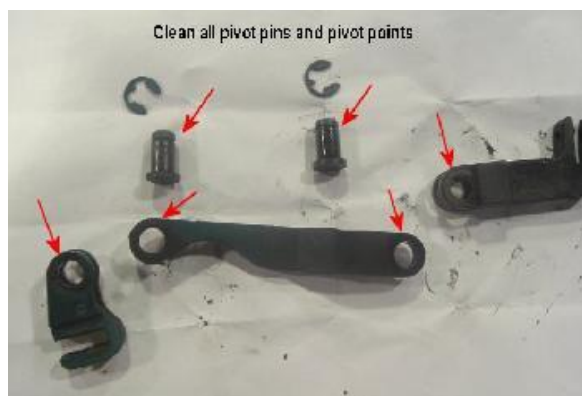
1. Remove the E clips from both of the fork lever pins and remove the pins.
2. Using emery cloth or a soft wire wheel, clean the inside of both fork levers, the ends of the intermediate linkage on both sides, and the fork lever pins

**Decision Step A:** If the linkages and pins are excessively worn (steps or elongated holes), replace the linkage.

**Decision Step B:** If the linkages and pins are not excessively worn, continue repair the linkage.

3. Apply anti-seize compound to all points of contact on the fork levers, pins, and the linkage using 1870706C1 Lubricant or commercially available equivalent.
