Title: Dual Throttle Pedal Harness Troubleshooting

Applies To: 7000 4000 Models with Dual Throttle Harness and Switch Installed.

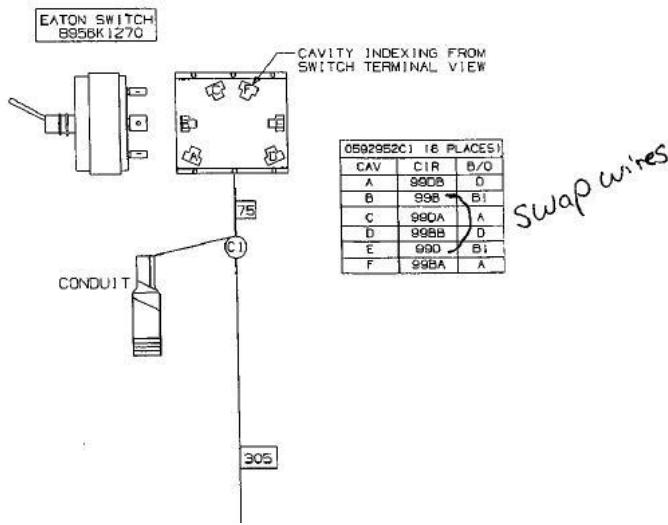
CIRCUIT DIAGRAM

Dual throttle pedals are inoperative.

- Will not accelerate
- Check engine light on

DTC	MODULE	DESCRIPTION
134	Engine	APS/IVS conflict

1. Check the wires on the back of the selector switch
2. Verify that wire 99B is in cavity B
3. Verify that wire 99D is in cavity E
4. If these are incorrect please swap the two wires.
5. If these wires are in the correct locations please follow the correct Iknow article for the aps troubleshooting.
