<b>Countries:</b>		<b>Document ID:</b>	IK1200948
<b>Availability:</b>	ISIS, Bus ISIS, FleetISIS	<b>Revision:</b>	1
<b>Major System:</b>	ENGINES	<b>Created:</b>	9/20/2013
<b>Current Language:</b>	English	<b>Last Modified:</b>	10/25/2013
<b>Other Languages:</b>	NONE	<b>Author:</b>	Caleb Iverson
<b>Viewed:</b>	135

**Title: High Temperature Exhaust Gas Recirculation Cooler Housing (HT EGRC) to Mid-Plate Alignment**

**Applies To: MaxxForce® 11 and 13, EPA 10, Navistar® N13 Engine, and 2013 MaxxForce® 13 HDOBD**

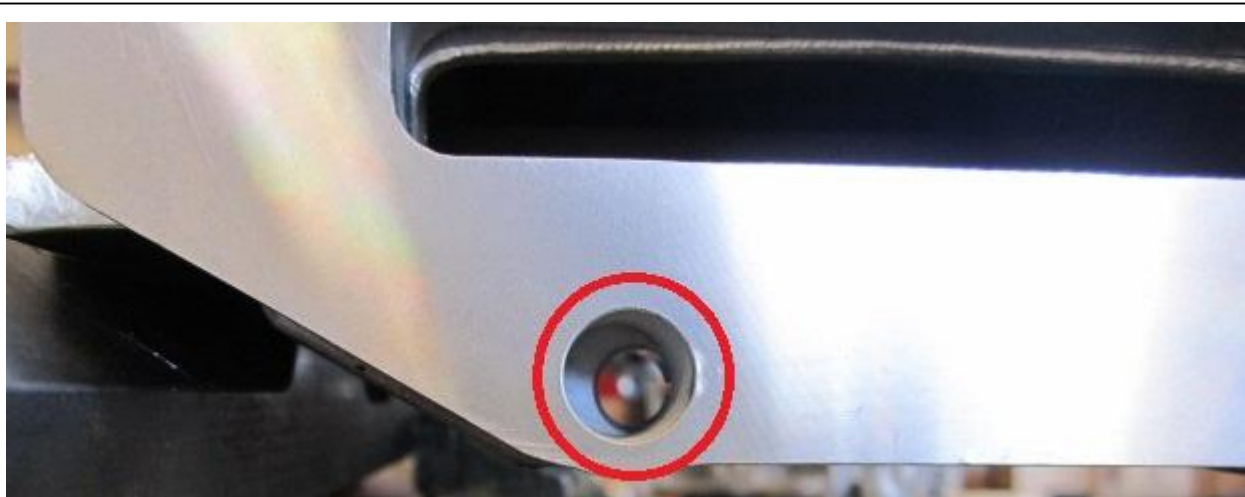
This procedure is to notify the Field that it is **NORMAL** to have an EGR Cooler Housing bolt hole pattern that is not directly lined up with the EGR Cooler Mid-Plate and also shows how to correct the misalignment.

**Red circle is the area of concern**

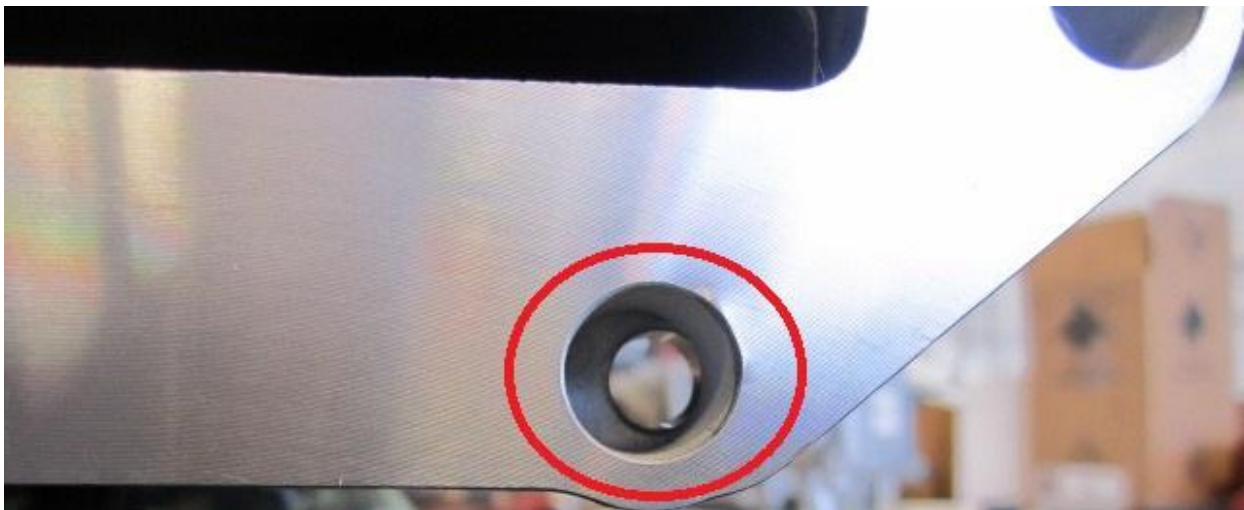
Red circle is the area of concern

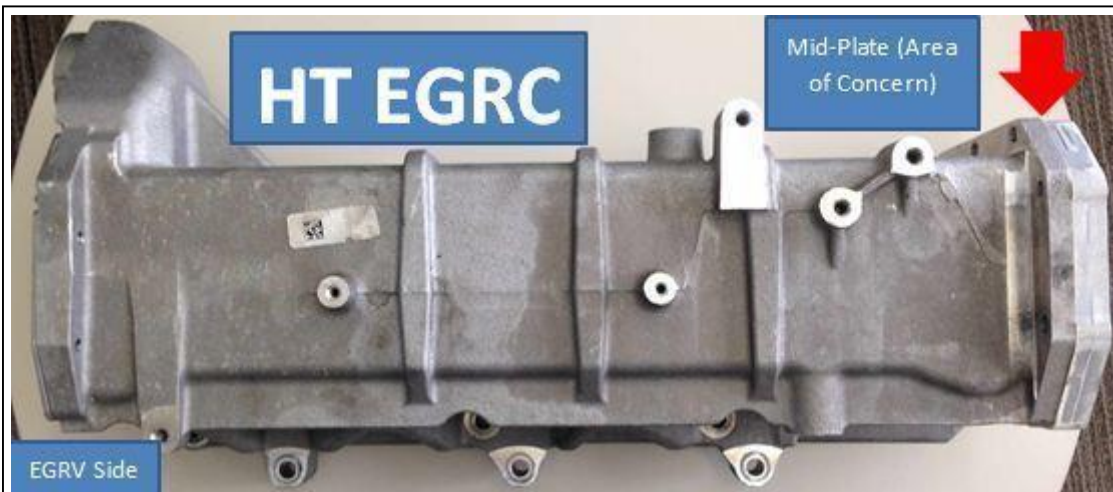
When receiving a new High Temp EGR Cooler assembly you may have an HT EGR Cooler that has a misaligned bolt hole pattern from the EGR Cooler Housing to EGR Cooler Mid-Plate. This is normal due to shipping and the assembly process. **DO NOT ORDER ANOTHER HT EGR COOLER.**

Red arrow is the area of concern

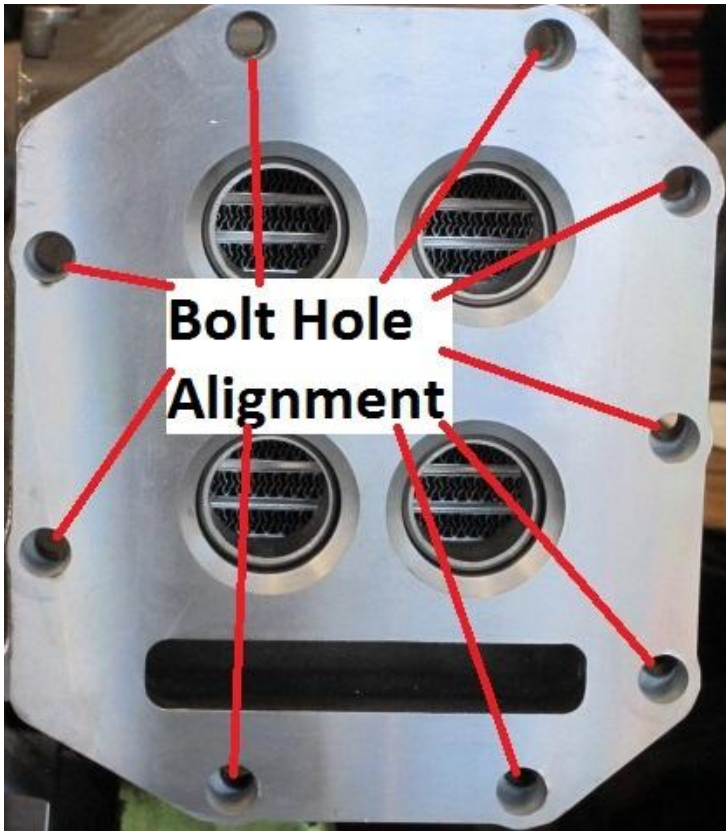
Red arrows are the area of concern

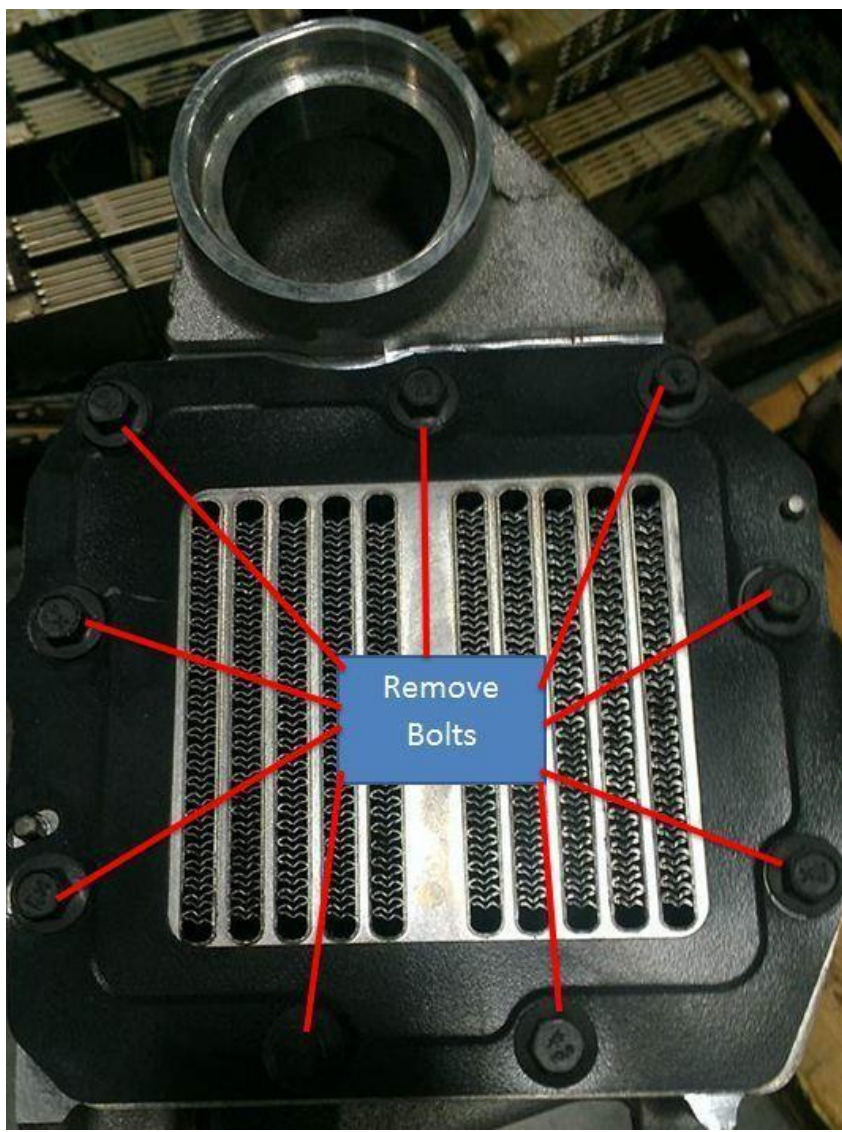
**Red arrows are the area of concern**
