**Countries:** CANADA, UNITED STATES **Document ID:** IK1600189  
**Availability:** ISIS, FleetISIS **Revision:** 2  
**Major System:** CAB / SLEEPER / HOOD **Created:** 9/18/2013  
**Current Language:** English **Last Modified:** 10/15/2013  
**Other Languages:** NONE **Author:** Patrick Gotschall  
**Viewed:** 215

**Title:** 9900i poor hood fit**Applies To:** 9900i built before 7/22/2013**DESCRIPTION**

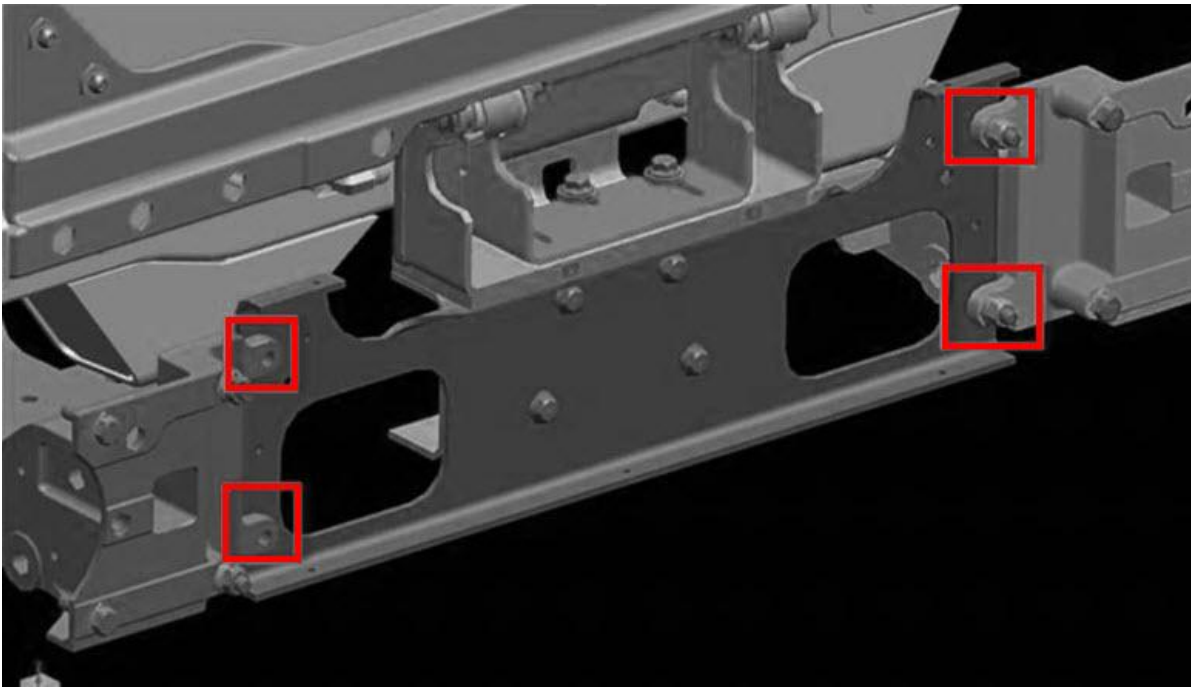
Two issues have been identified in association with poor hood fit on the 9900i. The hood is mounted incorrectly due to improper placement of the front crossmember. The result is that the hood is too far forward resulting in large gaps to the cab and modesty panels. Additionally, with the launch of ISX in June 2013, the hood hinge was redesigned to provide clearance to the new cooling package. However, some trucks were built with the incorrect (older) hinge. No interference would be observed because the hood is positioned too far forward. Once the cross-member position is corrected, trucks built with the older hinge will have an interference condition with the cooling package, so the old hing needs to be swapped with the new hinge (3565264C3).

**Figure 1: Front crossmember should be mounted behind the mega-bracket mounting tabs that are highlighted in the red boxes above.**

1. Inspect the front cross-member.
2. If it is mounted to the rear of the mega-brackets as shown in Figure 1, it is mounted correctly. Move to step 7.
3. If it is mounted to the front of the mega-brackets, it is mounted incorrectly.

5. Disassemble and reassemble the cross-member such that it's in the position as shown in Figure 1.
6. If the truck was built prior to 6/11/2013, reattach the hood. The job is complete.

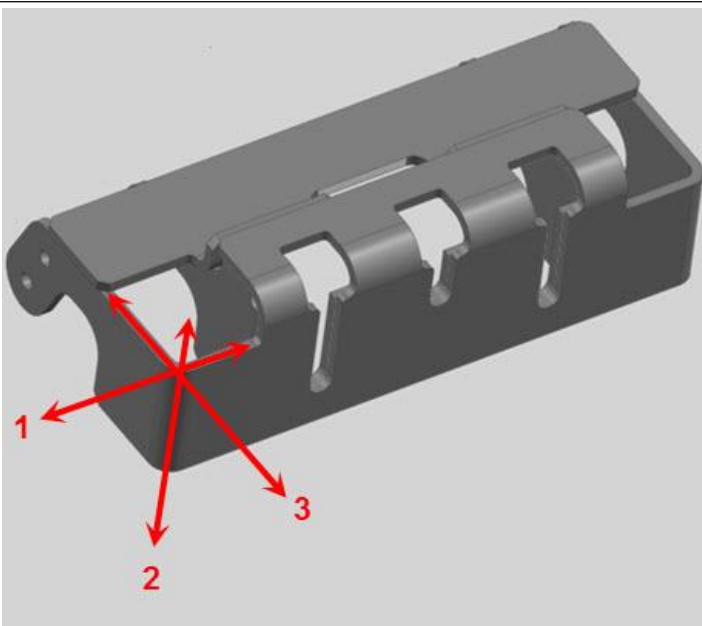
**Figure 2: Old hinge shown (Orientation from behind and below)  
For Reference: Direction 1 is cross-car, Direction 2 is fore-aft,  
and Direction 3 is up-down.**

7. If the truck was built on 6/11/2013 or later, inspect the hood hinge.
8. Refer to Figures 2 and 3 to determine if it is the old or new hinge.
9. If it is the new hinge, reattach the hood. The job is complete.

10. If it is the old hinge, replace the old hinge with the new hinge (P/N 3565264C3).
11. Reattach the hood, the job is complete.

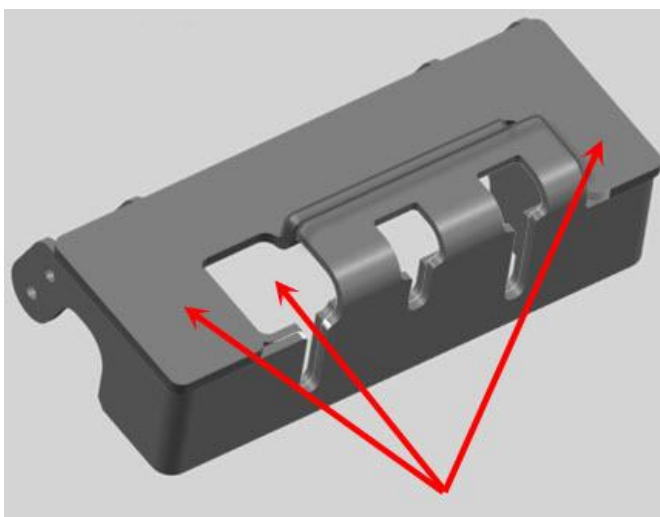
**Figure 3: New hinge (3565264C3)**  
Arrows point to areas that are different from the old hinge.
