Technical Service Information

TSI-13-12-18

Subject: High Temperature Exhaust Gas Recirculation (EGR) Cooler Housing to Mid-Plate Alignment

Engine Family: MaxxForce[®] 11 and 13 (EPA 10)

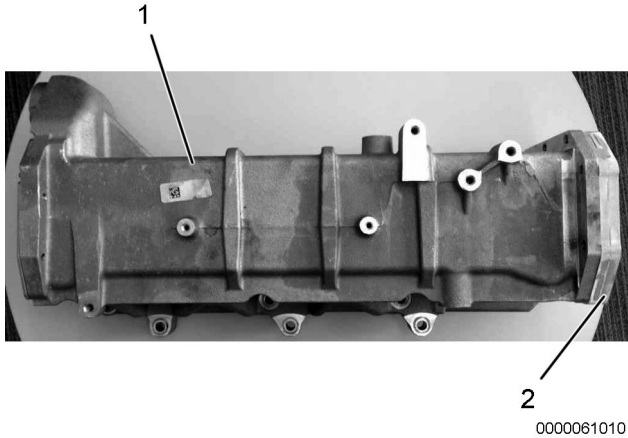
Figure 1. Mid-Plate Area of Concern.

NOTE: When receiving a new HT EGR cooler assembly, the HT EGR cooler may have a misaligned bolt hole pattern from the EGR cooler housing to EGR cooler mid-plate. This is normal due to shipping and the assembly process. **DO NOT ORDER ANOTHER HT EGR COOLER.**
