Countries: CANADA, UNITED STATES, MEXICO, PUERTO RICO Document ID: IK0700006  
 Availability: ISIS Revision: 2  
 Major System: EXHAUST Created: 11/14/2007  
 Current Language: English Last Modified: 12/13/2013  
 Other Languages: Français, Español, Author: Steve Kueller  
 Viewed: 8252

Title: Turbocharger Exhaust Pipe Leak - 2008 ProStar, TransStar 8600 and 9000 Trucks and Tractors

Applies To: ProStar and TransStar 8600 and 9000 with Cummins ISX ,ISM or CAT C13 Engines Built before 11-26-2007

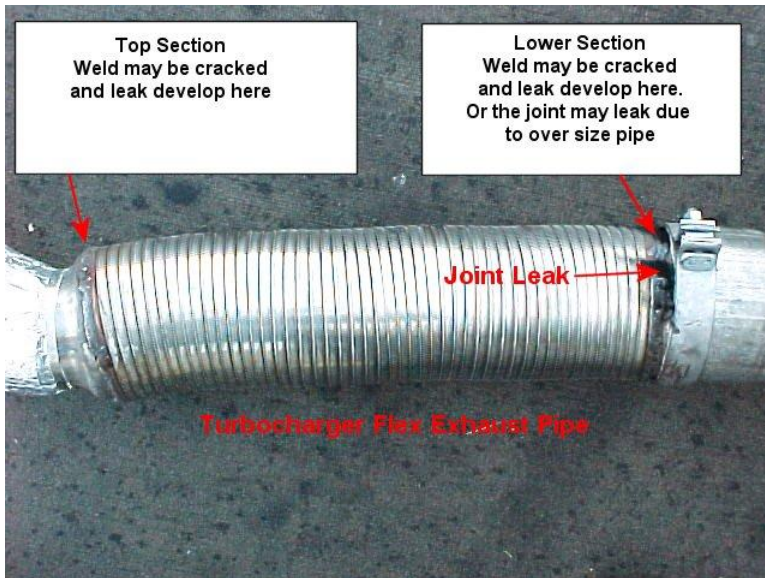
These leaks may be the result of poor or unfinished weld, poor weld between the flex pipe and solid turbo flange or outlet pipe, cracking of the flex pipe, or a poor fit between the turbo pipe to the intermediate pipe.

- Use a flashlight to look at the upper and lower section of the turbocharger flex pipe. Inspect the welds at the top and lower section of the pipe for leaks and cracked welds as shown in the photo below

Photo 1- Inspect Turbocharger exhaust pipe for cracked welds and leaks as shown.

Replace the correct pipe assembly as described here. Use appropriate pipe assemblies by VIN as listed in the parts catalogue. Only replace the turbo pipe **as an assembly do not try to just replace the flex portion**. Improved pipes went into production on 11/26/2007 **If you find a unit with exhaust leaks due to pipe fit or flexpipe cracking built after 11/26/07 you need to make a case file and contact tech service for further instructions.**

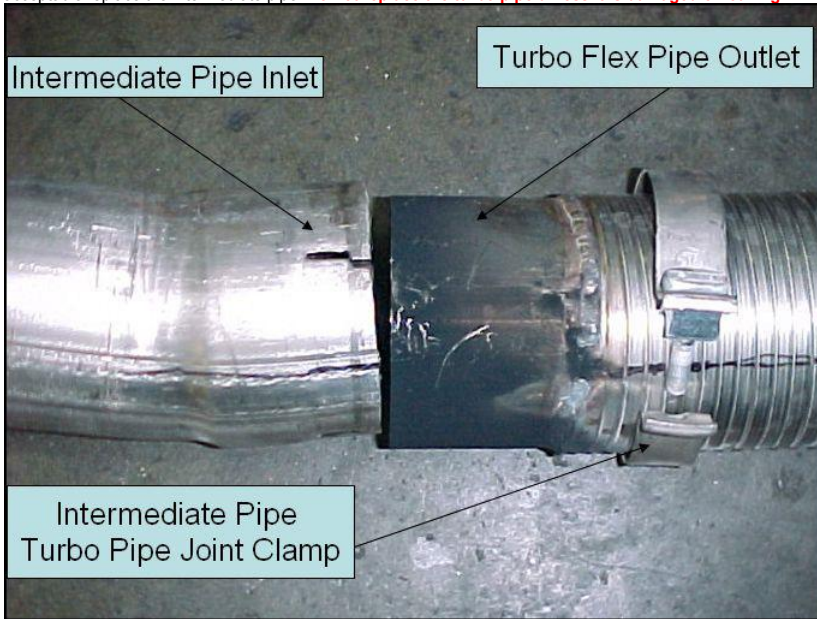
- a. If the leak is a result of poor joint fit between the Turbo Pipe (flex pipe) and the Intermediate pipe, carefully inspect the turbo pipe for any damage. If the turbo pipe is acceptable replace the intermediate pipe. **Do not replace the turbo pipe unless it is damaged or leaking!**

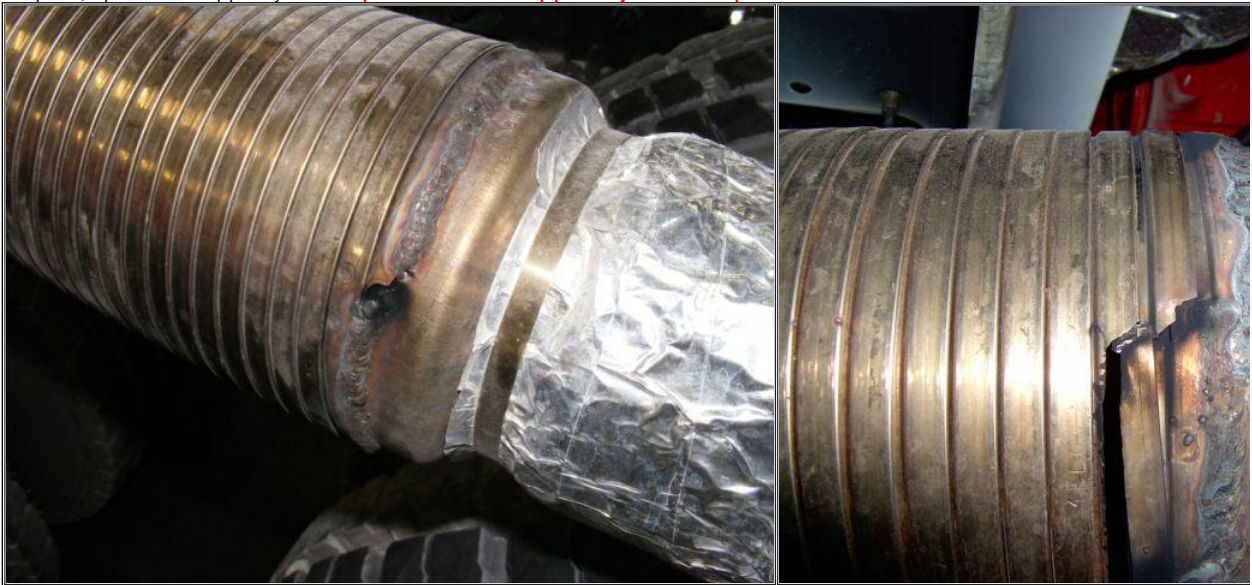
- b. If the leak is determined to be due to poor weld quality or the flexpipe has cracked as in pictures, inspect to make sure the joint fit is acceptable and not leaking. If joint fit is acceptable, replace the turbo pipe only. **Do not replace the intermediate pipe if the joint fit is acceptable**
