Document ID: IK0700019
Revision: 2
Created: 5/26/2010
Last Modified: 12/13/2013
Author: Steve Kueller

Title: Water Leaking from Exhaust Pipe Joint

Applies To: LoneStar Model equipped with Horizontal Aftertreatment and Vertical Tailpipe

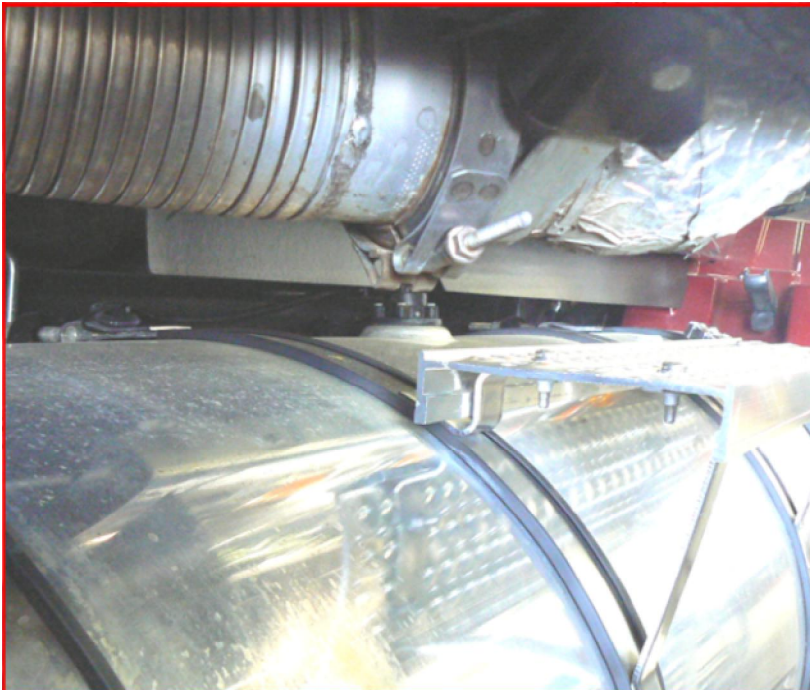
Water dripping from exhaust joint or clamp between the under cab flexpipe and lower tailpipe causing the fuel tank or skirt to stain.

- Fuel Tank Staining

Remove Clamp and Install Appropriate Gasket as Listed in Parts Information. Reinstall the clamp and torque to specs.
