Countries:	CANADA, UNITED STATES, PUERTO RICO	Document ID:	IK0700059
Availability:	ISIS, FleetSIS	Revision:	1
Major System:	EXHAUST	Created:	5/1/2013
Current Language:	English	Last Modified:	12/10/2013
Other Languages:	NONE	Author:	Keith Kierzek
Viewed:	711

Title: DEF Tank Slow to Fill

Applies To: 2013 Cummins ISX 15L

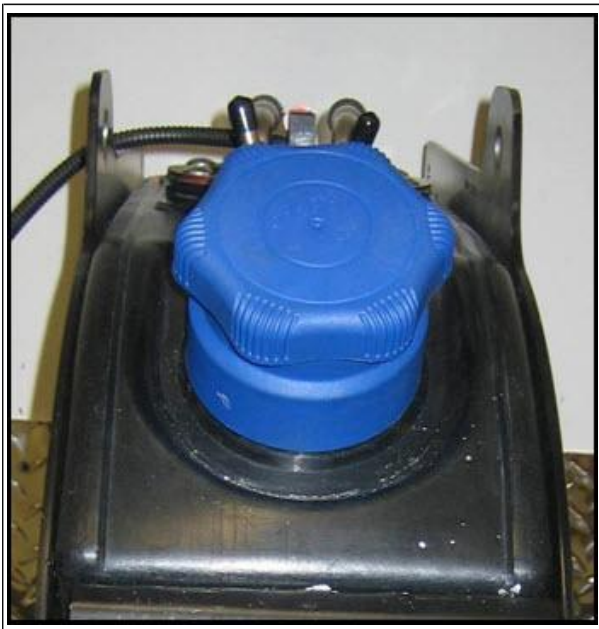
When filling a DEF tank with a high volume dispenser you may experience a backslash of fluid from the fill neck.
