| <b>Countries:</b> | CANADA, UNITED STATES, PUERTO RICO | <b>Document ID:</b> | IK0900014 |

**Title:** Front Spring Bolt Hitting Coolant Pipe on DuraStar and WorkStar Models built with feature 12WYK

**Applies To:** Post-2007 4000 and 7000 (WorkStar and DuraStar) models built with feature 12 WYK

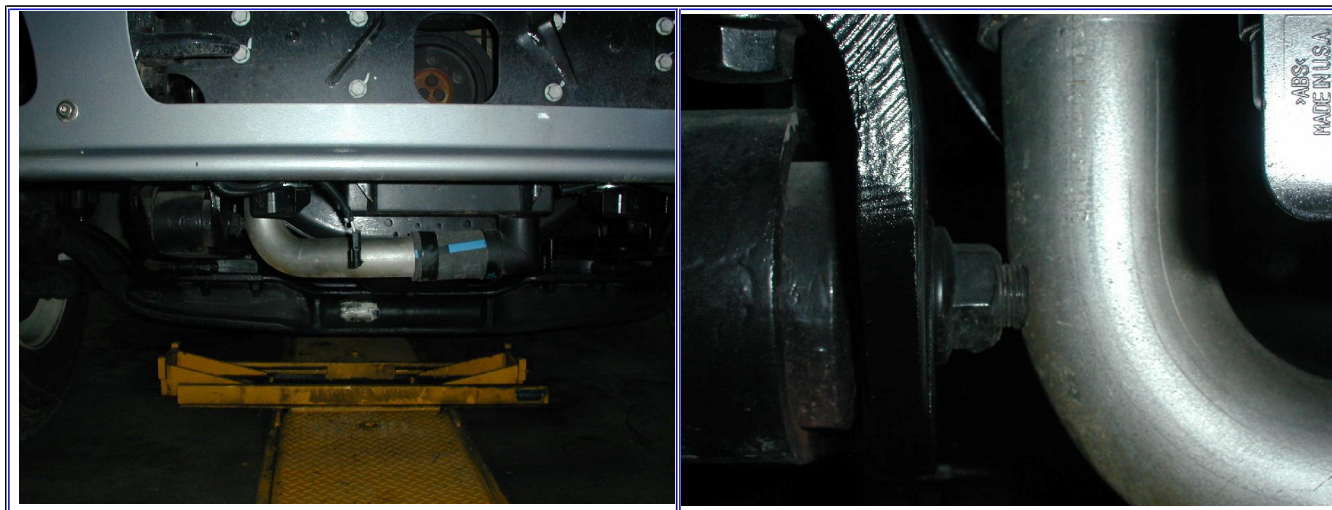
The spring bolt hits the coolant pipe for the auxilliary cooler on trucks built with feature 12WYK. This was fixed in production on 5/22/07.

- Hole rubbed into coolant pipe
- Coolant leak

Reverse the spring bolt so that the nut end is on the other side (curb side) and cut a half inch off of the bottom rubber hose so that the pipe will be further from the spring hanger.
