| <b>Countries:</b> | CANADA, UNITED STATES | <b>Document ID:</b> | IK1100031 |

**Title: Hard to Crank Condition on ProStar and LoneStar Vehicle**

**Applies To: ProStar and LoneStar Vehicles with Hydraulic Clutch Linkage and Solo Clutch**

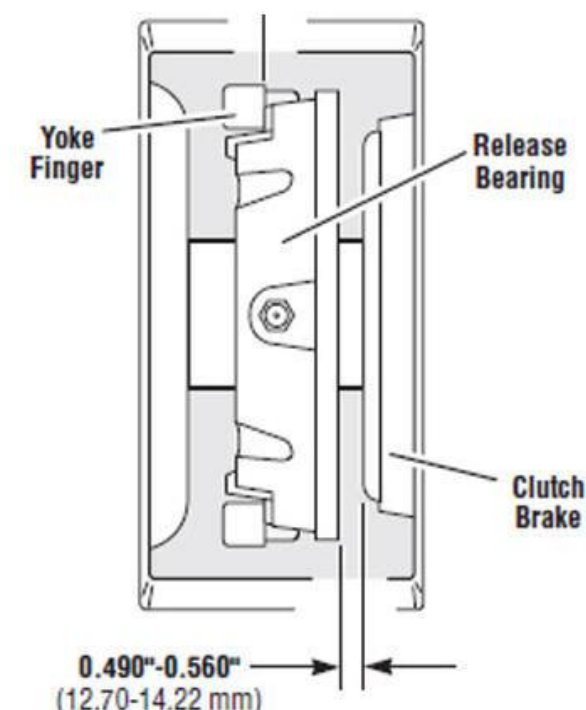
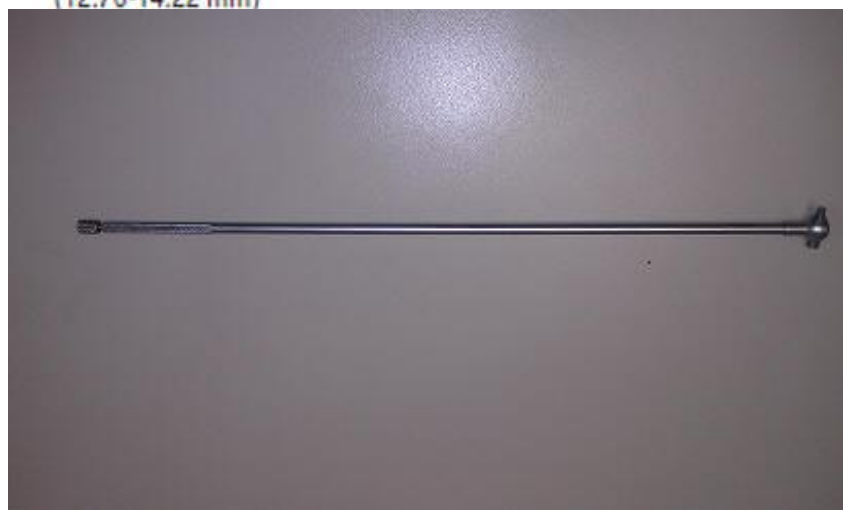
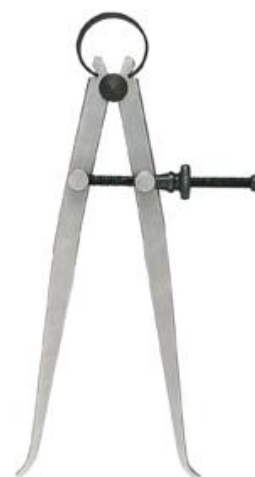
Remove the clutch inspection cover, and measure the bearing to brake position. Inserting a bar that is about 0.500" is NOT an acceptable procedure for checking the clutch bearing to brake measurement.

- Preferred Procedure- Use a telescoping gage or inside caliper capable of a 0.400" - 0.600" range, and insert it between the clutch bearing and the clutch brake aligned with the center of the brake and the center of the bearing. Then measure the gage using a micrometer or a dial/digital caliper.
- Alternate Procedure- Use a feeler gage set (shim stack), and stack the correct number and size feeler gages to allow the feeler gage stack to fit snugly between the clutch bearing and brake. Then measure the feeler gage stack using a micrometer or a dial/digital caliper.

Rotate the engine over by hand until the clutch serial number is visible, and record the clutch serial number.

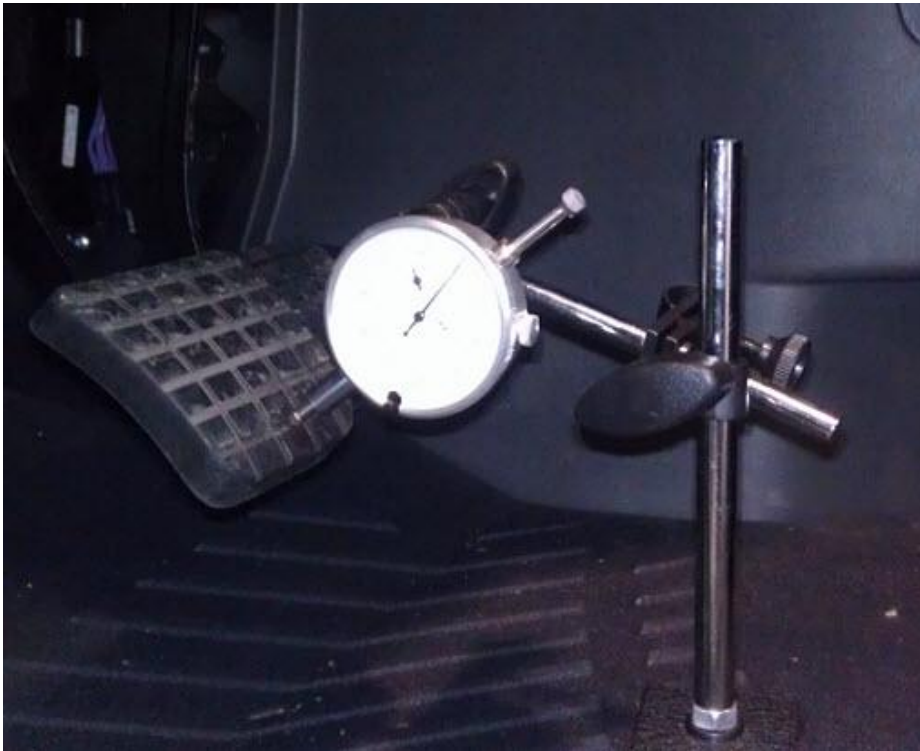
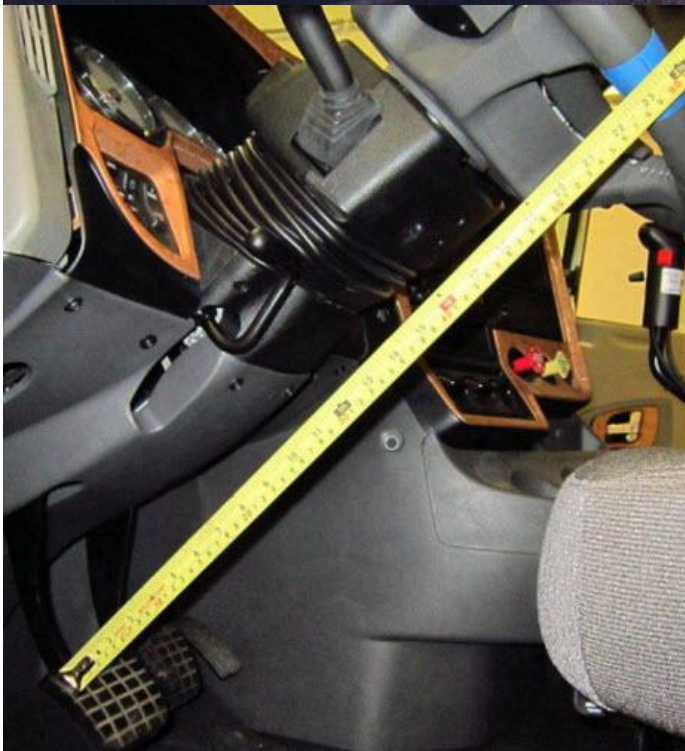
- Preferred Procedure- Use a dial indicator to measure the free play adjustment. When setting up the dial indicator, adjust the indicator so the needle does not slide across the pedal, but follows the pedal. This is the most accurate way to measure the clutch release pedal free play, and will allow the final adjustment point to be set accurately.
- Alternate Procedure- This should only be done if a dial indicator is not available. Using the tilt function on the steering column, align the steering wheel to the clutch release bearing travel position. Use a piece of masking tape and wrap the steering wheel in line with the clutch

release pedal. Mark a line on the masking tape and measure from the pedal to the line at the top of the pedal range and at the bottom of the free play range. Using the tape measure, adjust the clutch release pedal free play to 3/4".

If the clutch release pedal requires excessive effort to allow the vehicle to crank, then adjust the clutch release pedal free travel to 0.700"-0.800" from the factory setting of 0.400"-0.600". This allows the pedal to travel up to an extra 2-3 degrees, allowing the vehicle to crank with reduced pedal effort force. Do not exceed 0.800", or the clutch brake operation may be compromised.

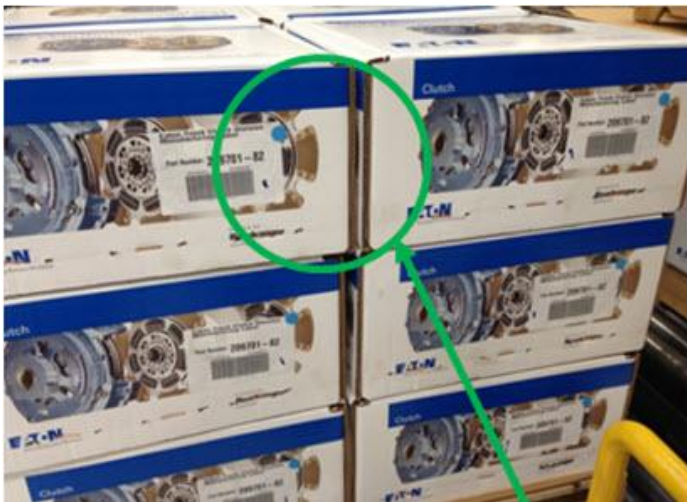
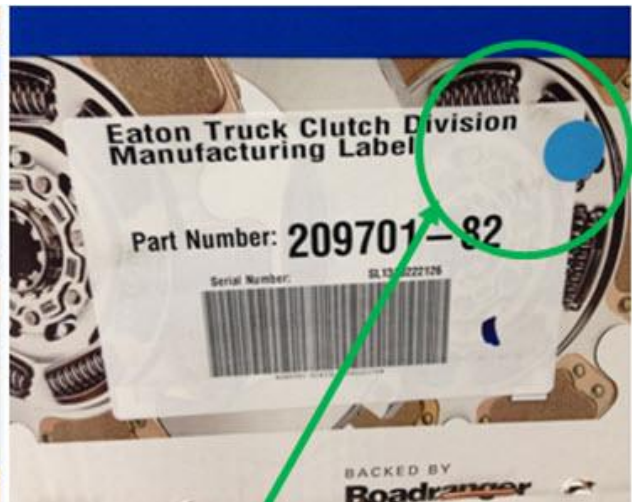
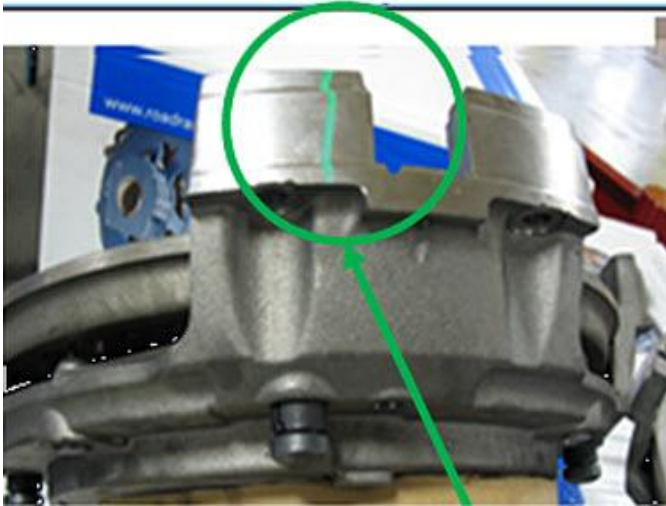
Please see the below photos to identify a replacement clutch. These are clutches that must be used on all ProStar and LoneStar vehicles. Vehicles with a mechanical linkage system can continue to use clutches without the markings. All these clutches are certified to have a bearing gap above 0.530" at the Eaton end of line tester. These clutches can be identified by the following witness marks:

- A blue dot placed on the corner of the part label on the box
- A green line on the pressure plate ear nearest the cam tab

To ensure you receive a clutch that has a blue dot, please order a clutch from the PDC. When ordering the clutch, notate on the order " Please ensure the label on the clutch box has a blue dot on it, per IK1100031"
