**Document ID:** IK1200433

### Title: I326 Variable Geometry Turbo: Supplemental Diagnostics

**Applies To:** International MaxxForce DT, 9, and 10 Diesel Engines (2007 through 2009 MY), Serial number range: 3000000 through 3299999.

This document is a diagnostic and repair guide for 2007 through 2009 model year Variable Geometry Turbo (VGT). Use it as a supplement to ISIS versions EGES-335 and EGES-370.

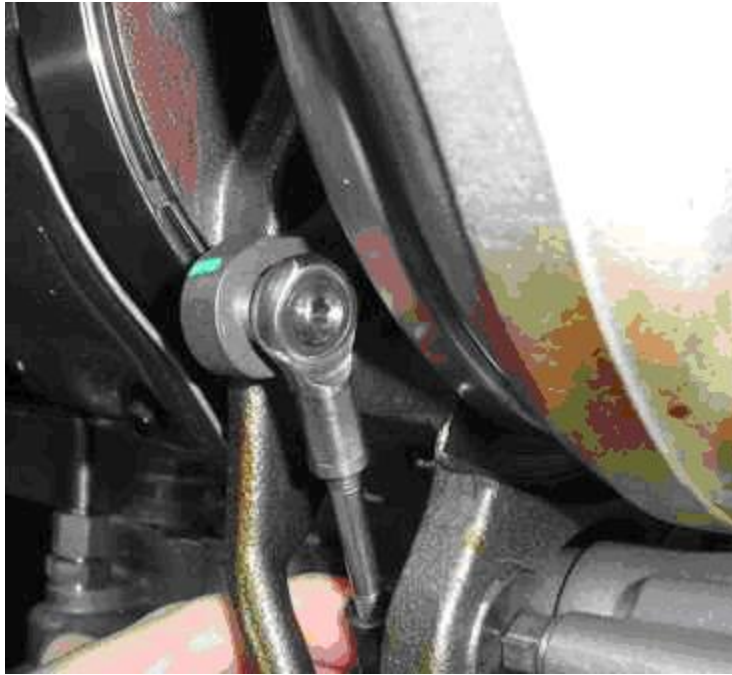
## Serviceable Linkage (Allen-head bolt)

**Serviceable SRA only—ball joint attached with 4mm Allen-head screw (I-6 engines with ESN 3032558 and later)**

1. Unthread 4mm Allen-head screw to remove the link.
2. Push the linkage by hand to the opposite end of travel and release:
  - a. If the arm is stuck, dragging, or cannot move then replace the SRA.  
Note: additionally the turbine housing pivot arm is expected to move free.
  - b. If the arm moves smoothly with a spring-like resistance replace the turbine housing.  
Note: additionally the turbine housing arm is expected to be stuck or resist movement.
3. Repeat Part A.

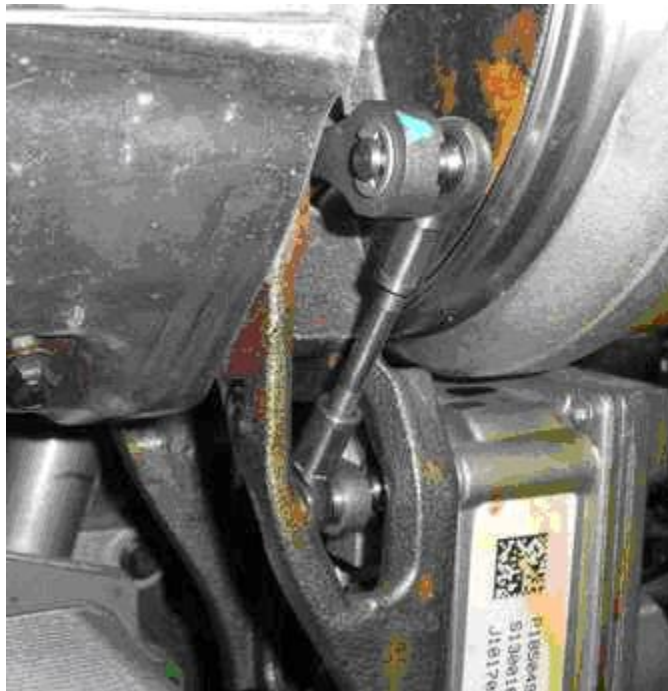
## Non-serviceable Linakge (with E-clip)

#### *Non-serviceable SRA only—ball joint secured with e-clip (do not attempt to remove)*

1. Remove turbocharger assembly—See “Variable Geometry Turbocharger (VGT)” section in *Engine Service Manual* EGES-335-1 or latest revision.
2. Disassemble Turbo Housing per iKNow article IK1200432 *Disassembly* section . Push the linkage by hand to the opposite end of travel and release:

- a. If the linkage moves smoothly with a spring-like resistance and returns to its original position then replace the turbine housing.
- b. If the linkage is stuck, dragging, or does not return to its starting position then replace the turbocharger assembly.
