**Document ID:** IK1201044  
**Revision:** 0  
**Created:** 12/17/2013  
**Last Modified:** 12/17/2013  
**Author:** Aaron Wenthold

**Title: EGR Cooler Leak Test Tool Leaking**

**Applies To: 2010 and 2013 Emissions MaxxForce DT, 9 and 10**

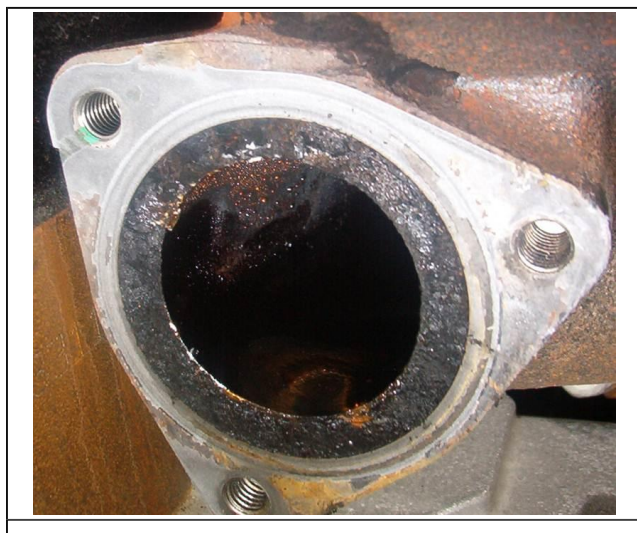
1. Always clean the exhaust inlet face with a brush, emory cloth or sand paper. Any soot or corrosion build-up can cause the tool plug to leak.

**Figure 1: EGR Cooler inlet with build-up**

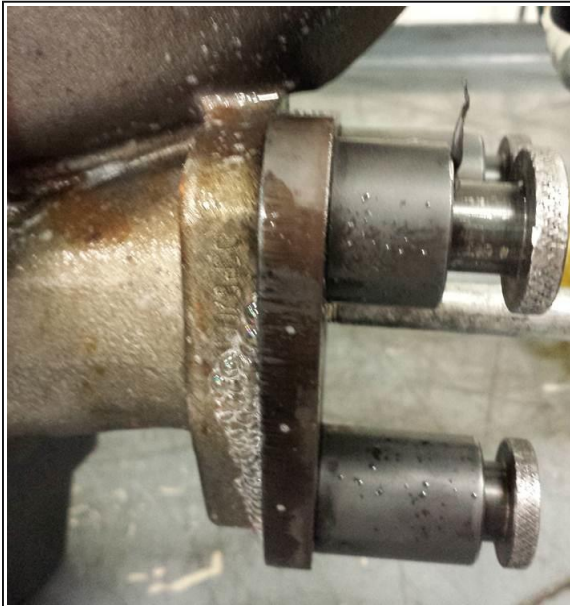
**Figure 2: EGR Cooler inlet leak test**

A soap test reveals that the **uncleaned** flange cannot be sealed completely with the leak test plate.

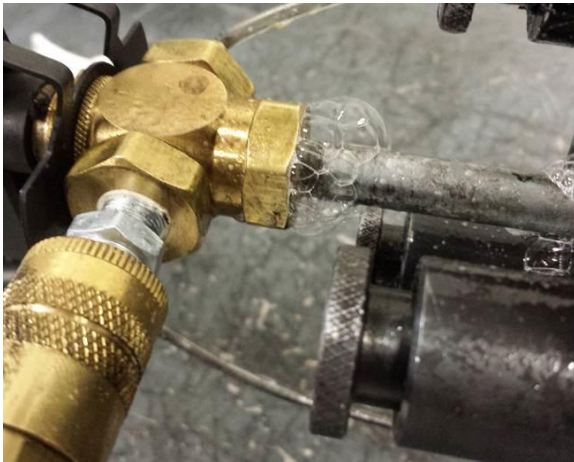
**Figure 4: Air fitting leaking at "T" connector**

All leaks will (falsely) appear to be a failed cooler during leak decay testing, so it's important to periodically ensure your tool is not defective.

2. When testing the cooler with the leak testing tool, use soapy water to check for leaks at the joints. If any are found; remove, use thread tape/sealant and retighten the respective fittings. If the leaks are non-repairable, please contact the Navistar Tool Group for assistance.
