**Countries:** AUSTRALIA, BRAZIL, CANADA, UNITED STATES, PUERTO RICO, SOUTH AFRICA  
**Document ID:** IK1500004  
**Availability:** ISIS  
**Revision:** 3  
**Major System:** FUEL SYSTEMS  
**Created:** 12/14/2006  
**Current Language:** English  
**Last Modified:** 12/23/2013  
**Other Languages:** [Français](#), [Español](#),  
**Author:** Frank Amstadt  
**Viewed:** 1441

**Title: The Dual Fuel Tank Transfer Pump Appears To Be Operating Intermittently**

**Applies To: All HPV Built between March and August of 2004 with dual fuel tanks**

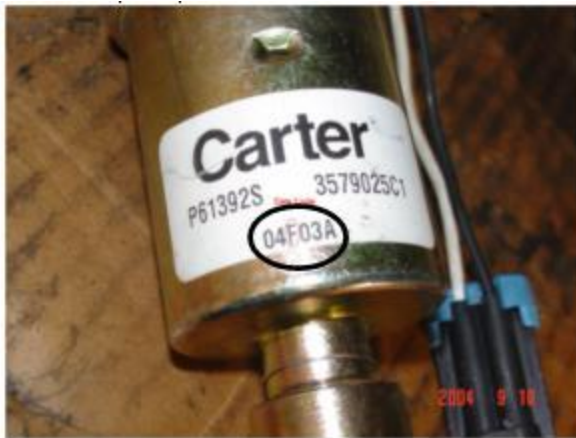
Trucks built between March and August of 2004 are susceptible to intermittent pump operation because the pumps printed circuit board may have a capacitor installed incorrectly or the pump housing may be bent, either of which can cause the pump to operate erratically. Figure 1 shows where the date code (circled) is located on the pump. If the third character in the date code is either E or F the capacitor could be installed incorrectly. Figure 2 shows a pump that has had the end bent. If troubleshooting indicates the pump is the cause of improper fuel tank equalization and the transfer pump exhibits either of these two conditions, the pump should be replaced.
