Countries:	CANADA, UNITED STATES	Document ID:	IK0700059
Availability:	ISIS, FleetSIS	Revision:	0
Major System:	EXHAUST	Created:	5/1/2013
Current Language:	English	Last Modified:	5/2/2013
Other Languages:	NONE	Author:	Jim Restemayer
Viewed:	275

Title: DEF Tank Slow to Fill

Applies To: 2013 Cummins ISX 15L

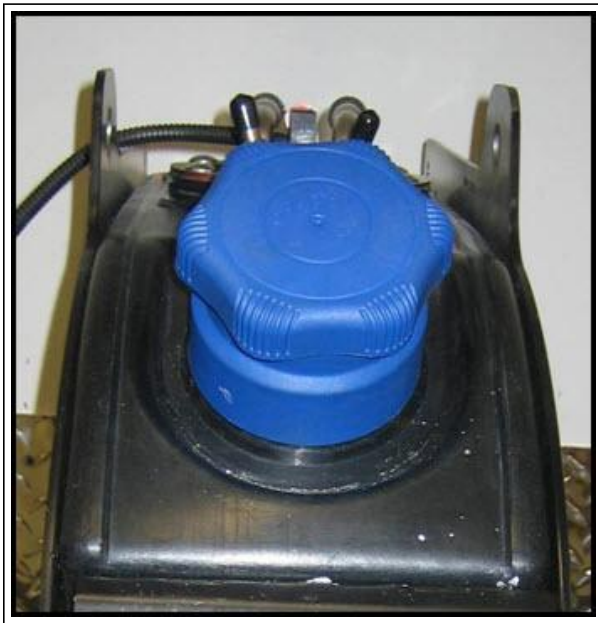
When filling a DEF tank with a high volume dispenser you may experience a backslash of fluid from the fill neck.
