Countries:	CANADA, UNITED STATES	Document ID:	IK1600178
Availability:	ISIS, FleetISIS, Body Builder	Revision:	0
Major System:	CAB / SLEEPER / HOOD	Created:	3/5/2013
Current Language:	English	Last Modified:	5/29/2013
Other Languages:	NONE	Author:	Patrick Gotschall
Viewed:	71

Title: TerraStar Torsion Bar Retention Cotter Pin Design Change

Applies To: TerraStar built before 1/31/2013

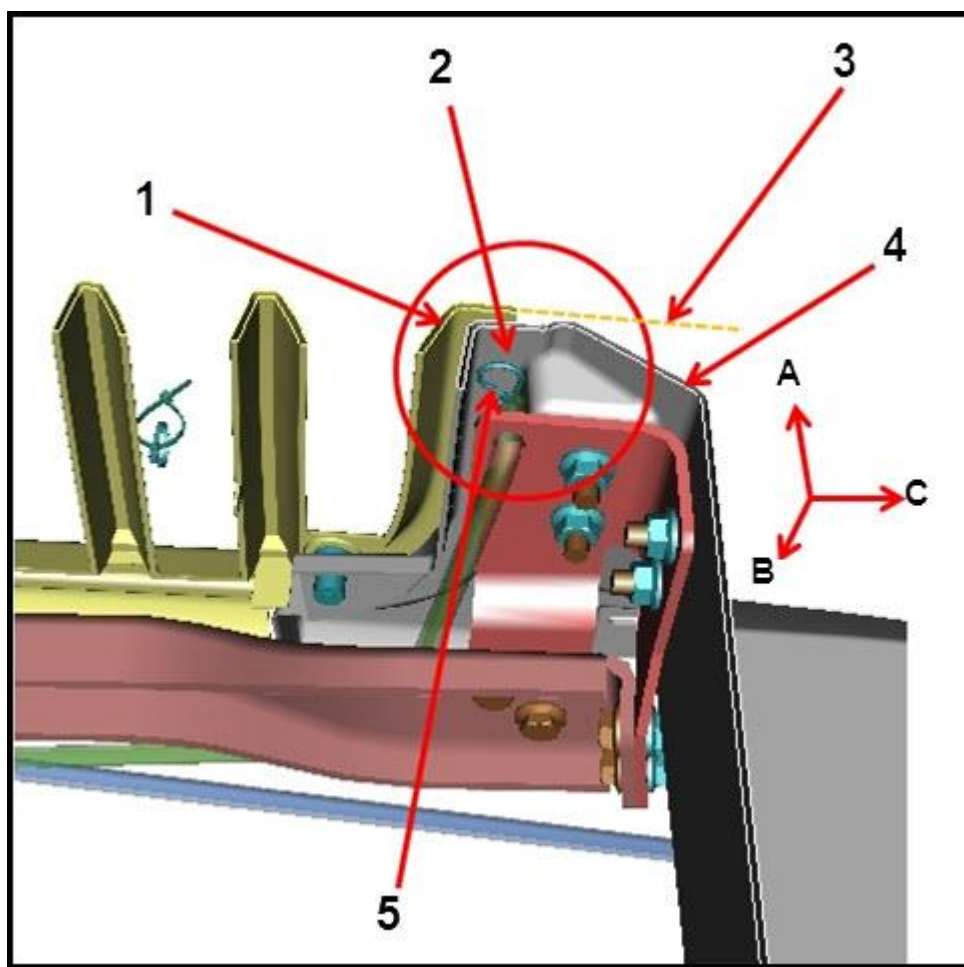
Figure 1

There has been a design change to the TerraStar torsion bar retention pin due to the possibility of the pin rotating and then wearing against and/or cracking the Grille Opening Reinforcement (GOR). This is a cosmetic issue that is normally hidden by the grille and the headlamp, however it may be discovered if these parts are removed for service.

1. Overview of area affected (section through grille/hood looking forward and down) (*Figure 1*):

1. Grille
2. Point of crack or puncture
3. Headlamp bezel (not shown, simulated with dotted line)
4. Grille Opening Reinforcement (GOR)
5. Cotter pin

A replacement cotter pin with a smaller loop has been put into production as of 1/31/2013. Should it be desired, the cotter pin on the trucks built prior to this date may be swapped with P/N 6102322C1 (the old part number was 3531907C2).

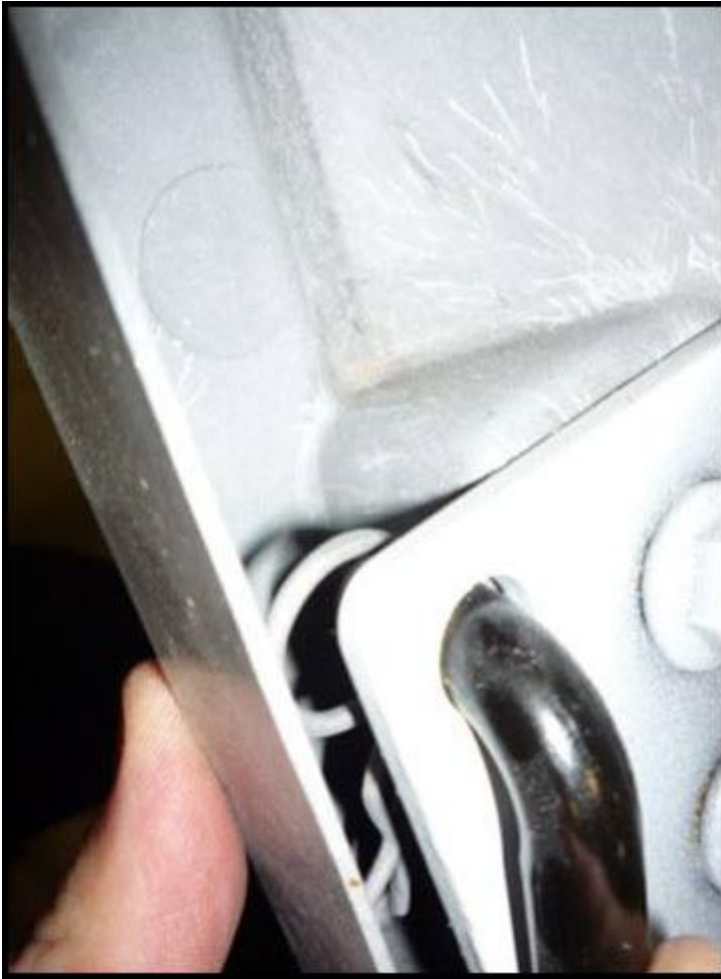
Figure 2

2. Pin as it should be installed (*Figure 2*).

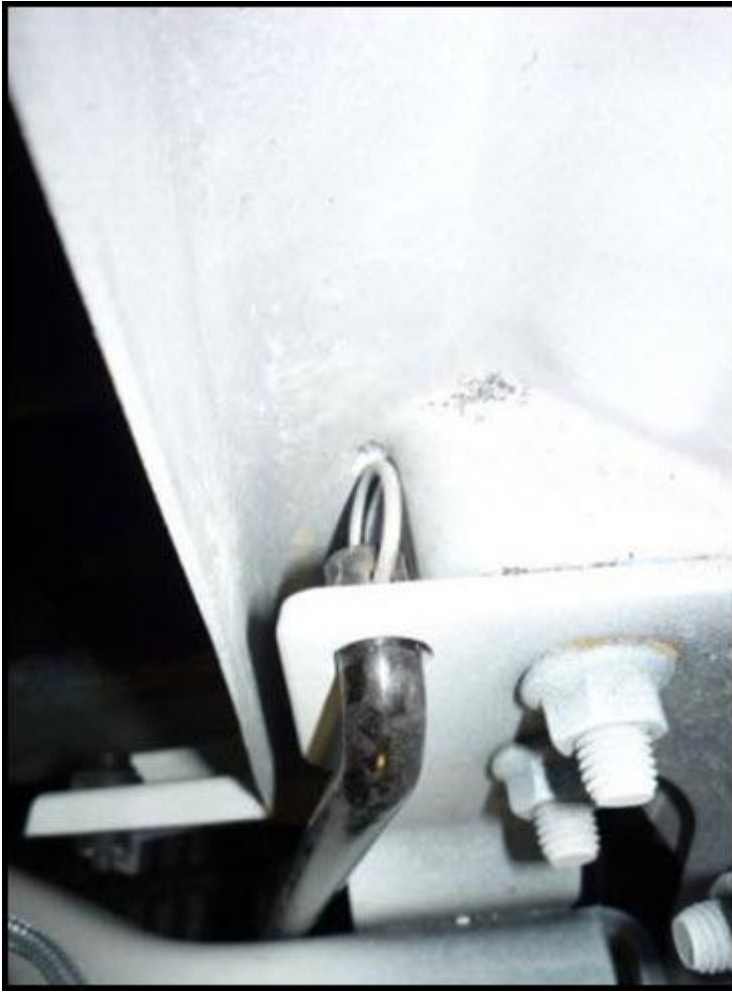
Figure 3

3. Pin that has turned and is rubbing on the GOR (*Figure 3*).

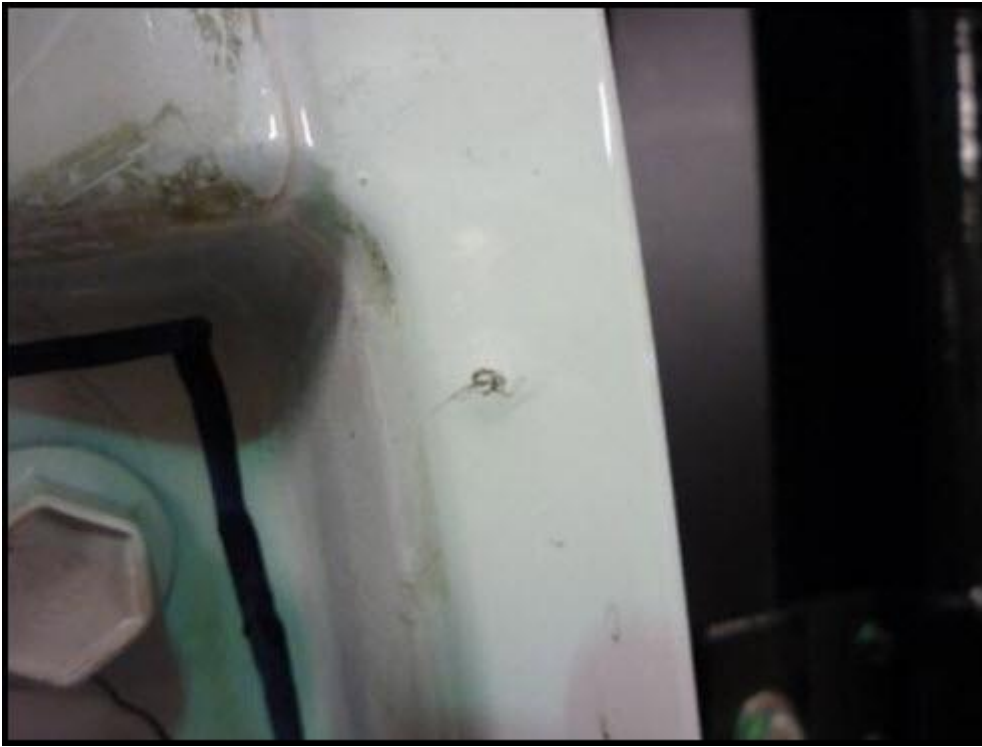
Figure 4

4. Evidence of cracking on GOR due to pin (this is normally obscured by the headlamp and grille) (*Figure 4*).

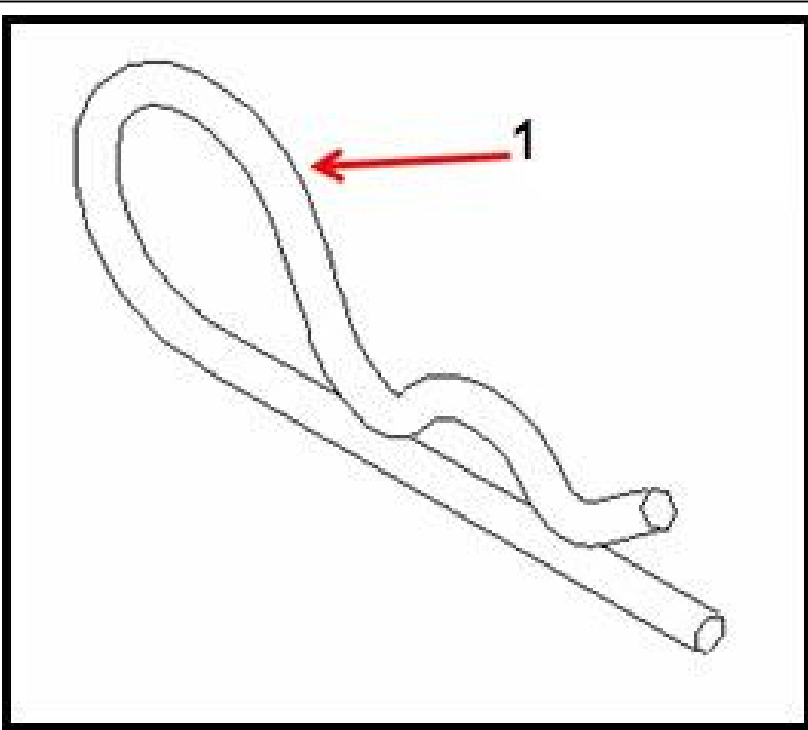
Figure 5

5. Differences between old and new cotter pin (*Figure 5*).

1. Loop reduced from 5/8" to 3/8"
