SP13-18 Corrosion on Evaporator Door Stopper

March 2013

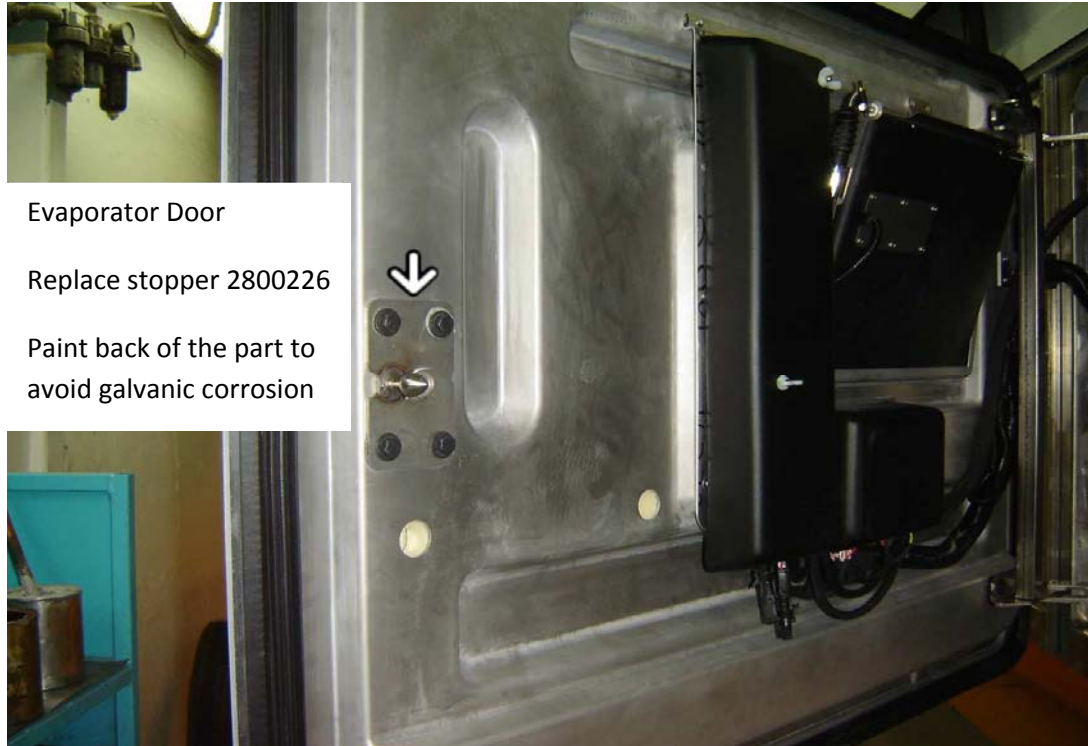
Context : Possibility of galvanic corrosion between the aluminium door and the stainless steel evaporator door retaining mechanism (2800226);

The back of the part must be painted to avoid GALVANIC CORROSION

On evaporator door, replace **2800226 QTY 1** (if needed, use *BOLT 5001745* , *WASHER 500321*)
