## **SP13-23** BI-METAL CONTACT AT SIDE REFLECTOR (R13031)

ON X3-45 COACHES

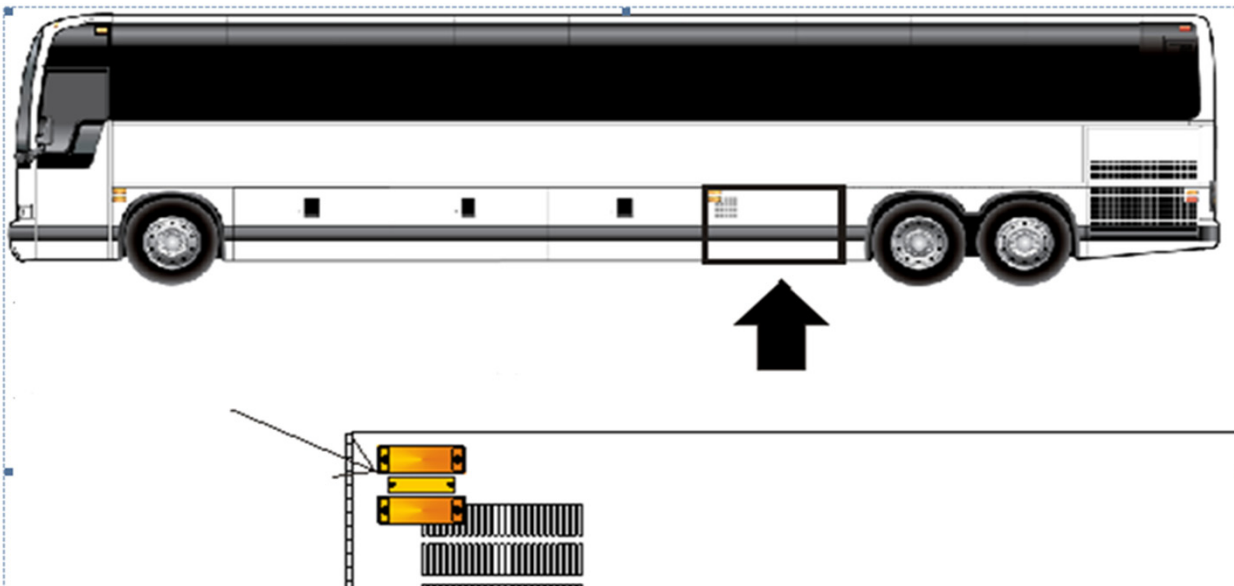
THERE IS A RISK OF BI-METAL CONTACT (STAINLESS STEEL & ALUMINUM) LEADING TO CORROSION WHERE SIDE REFLECTOR IS INSTALLED ON THE EVAPORATOR DOOR.

VEHICLES WITH THE NEW ALUMINUM DOOR ARE INVOLVED

REMOVE THE SIDE REFLECTOR LOCATED ON THE EVAPORATOR DOOR

ENLARGE THE FIXING HOLES TO A DIAMETER OF 5/16" (8mm)

REINSTALL REFLECTOR USING :

**NUT WELL #500678 QTY 2**

**SCREW #5001305 QTY 2**
