## TITLE: INVERTER POWER CABLE RUBBING

Prevost vehicles

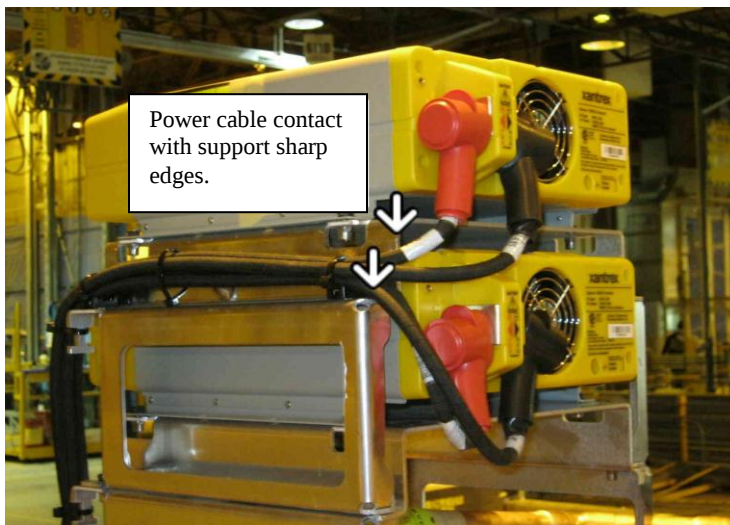
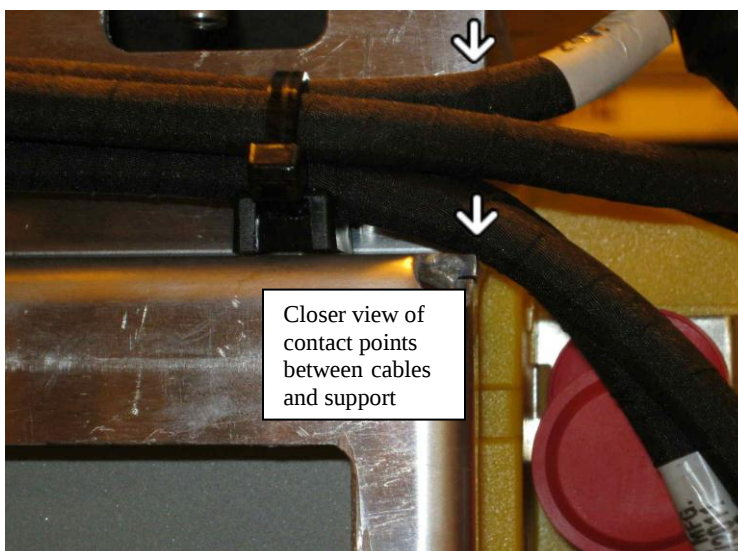
On the vehicles affected by this bulletin, a contact possibility exists between the power supply cable and the support sharp edge of the 24VDC/120VAC/1800 watts inverter (Part # 563082), leading to premature wear of the cable insulating tape. Follow the procedure described below to rectify the vehicle. / Sur les véhicules visés par ce bulletin, il existe une possibilité de contact entre le câble de puissance et l'arête vive du support de l'onduleur 24VDC/120VAC/1800 watts (Pièce # 563082) qui peut occasionner une usure prématurée de la gaine protectrice du câble. Suivre la procédure ci-dessous pour rectifier les véhicules.

- 1) To access the inverter and cables, open the mirror door located in the lavatory compartment at the rear of the vehicle.
- 2) Locate the three cables and the tie mount near the sharp edge of the inverter support (connection side of the inverter).
