PREVOST

WARRANTY BULLETIN

WB13-32B

DATE :	JUNE 2013	SECTION :	04 - Exhaust
EXPIRATION:	JUNE 2015		
SUBJECT :	NOX SENSOR REPLACEMENT & SOFTWARE UPDATE

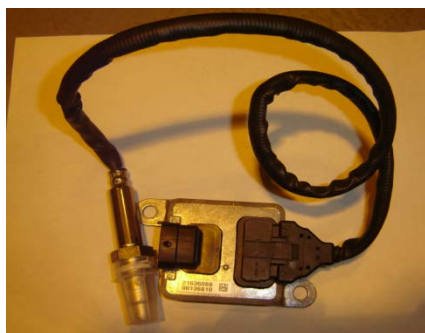
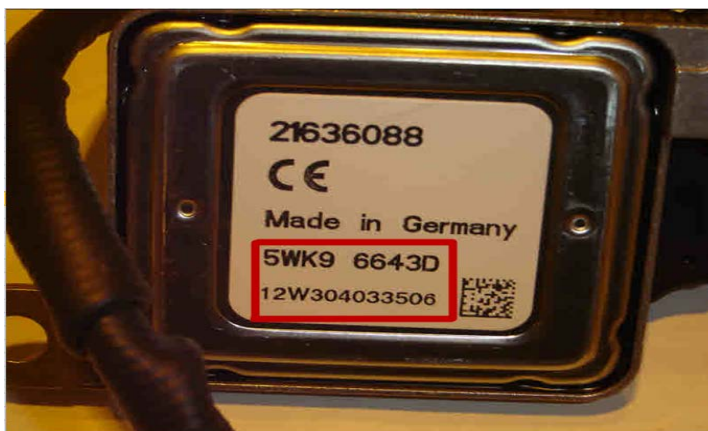
(Located at the back of the electronic module).

1. Open the SCR access door.
2. Write down new electronic module serial number before installing.

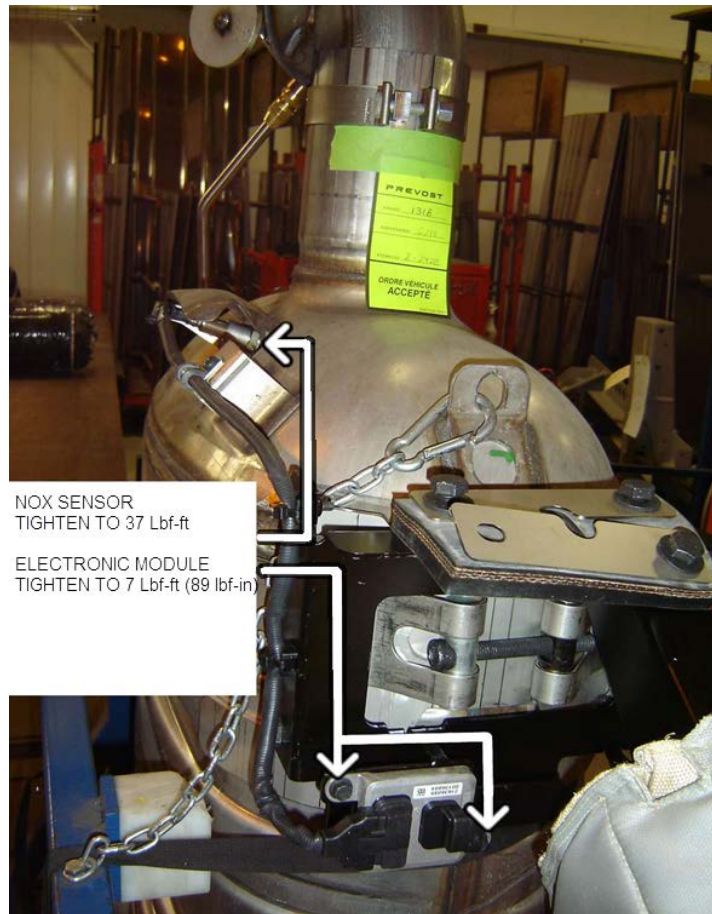
NOX SENSOR
TIGHTEN TO 37 Lbf-ft

ELECTRONIC MODULE
TIGHTEN TO 7 Lbf-ft (89 lbf-in)

3. Replace NOx sensor 21636088 by 22014032
4. Tighten sensor to 37 lbf-ft
5. Tighten mounting bolts to 7 lbf-ft (89 lbf-in)

6. Support with clips and cable ties
