REVISION A Supercedes previous versions  
July 19,2013 Updated to latest software numbers

**TITLE: ACM PROGRAMMING & RELAY ADDITION**  
Prevost vehicles

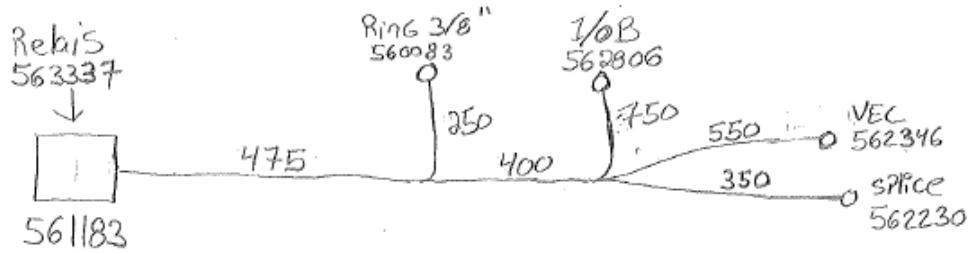
### H-SERIES for ref only.

On the vehicles affected by this bulletin, a relay needs to be added to allow the DEF to return to the tank after turning the key to the OFF position. In addition, the ACM & MCM need to be reprogrammed to the latest version.

1. Connect patch harness to relay
2. Connect wire 00B to electronic ground post
3. Remove 24VD8 on VECR10:E and splice to new 24VD8 wire
4. Connect wire 24VD8C to VECR 10:E
5. Route wire 425 towards A51
6. Connect wire 425 to A51:J1:20
