Date	Expiration	Release	Page
05.2013	05.2015	1	1

90 DEG ELBOW WITH 5 LAYERS Prevost vehicles

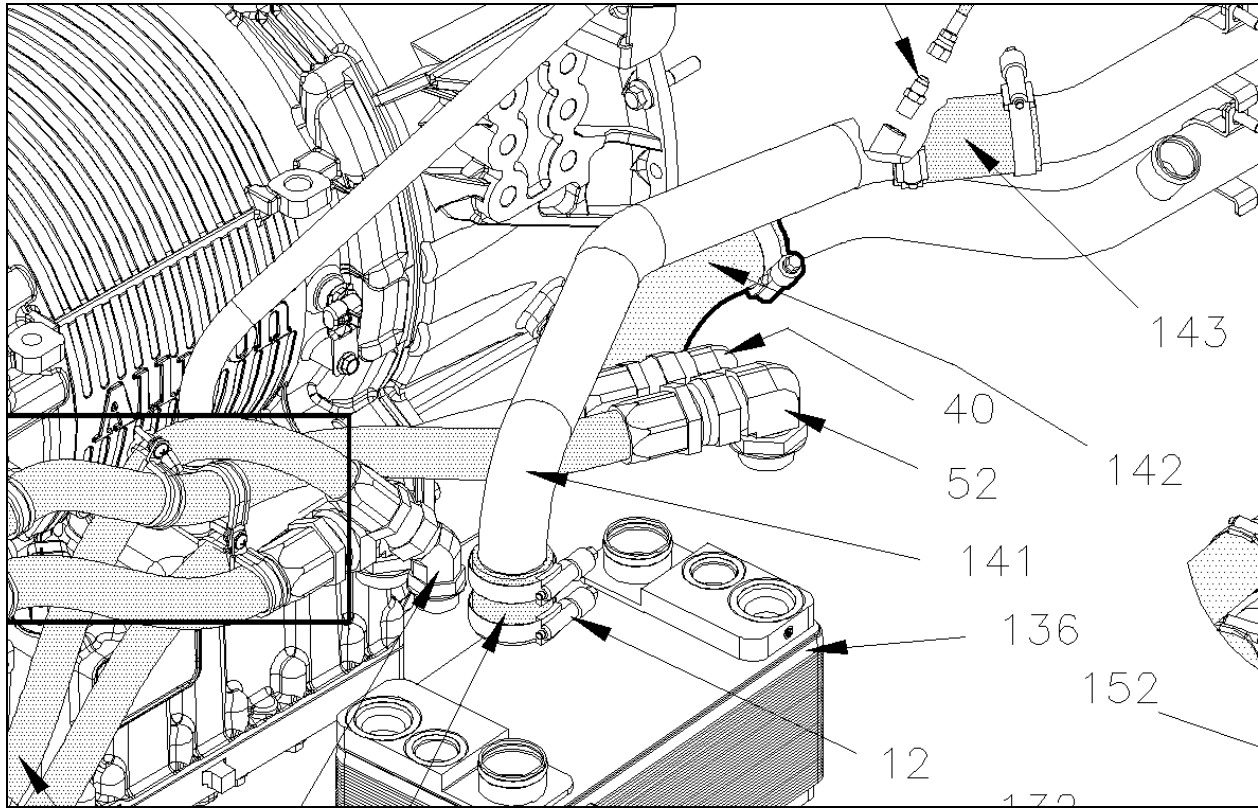
Figure 1: 052898 (142)

On the vehicles affected by this bulletin, an improved 90 degree elbow is available. Proceed to replacement at next service occasion.
