PREVOST

**WARRANTY
BULLETIN**

WB13-29

DATE :	MAY 2013	SECTION :	05 - Cooling
EXPIRATION:	MAY 2015		
SUBJECT :	LOOSENING BOLT ISSUE - COOLING FAN CLUTCH TRIPOD

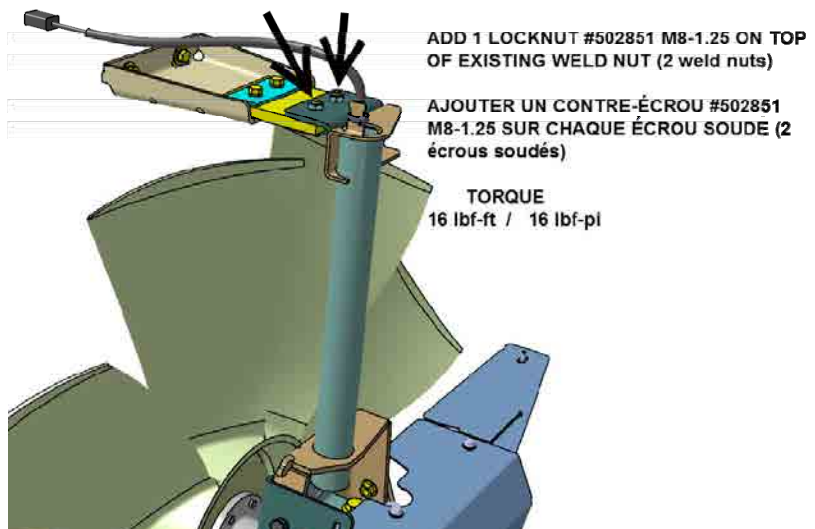
On the vehicles affected by this bulletin, a corrective measure is required due to bolts coming loose at the radiator fan clutch tripod attachment to the radiator. Bolts tend to get loose because they are tightened on a part made of rubber. Addition of four (4) locknuts (jam nuts) will prevent bolts to loosen and consequently, the radiator fan from striking the radiator core if the assembly fails.

4. **ALL TYPES.** Add two locknuts #502851 as described on the image at right. **If needed, tighten the bolt a little bit more to show more threads.**
