SP13-42: INTERFERENCE BETWEEN CEILING AND GAS SPRING ON SOME LUGGAGE DOORS
REFER TO SAP FOR CODES AND VEHICLES
VEUILLEZ VOUS RÉFÉRER AU RETROFIT R13043 POUR LA VERSION FRANCAISE

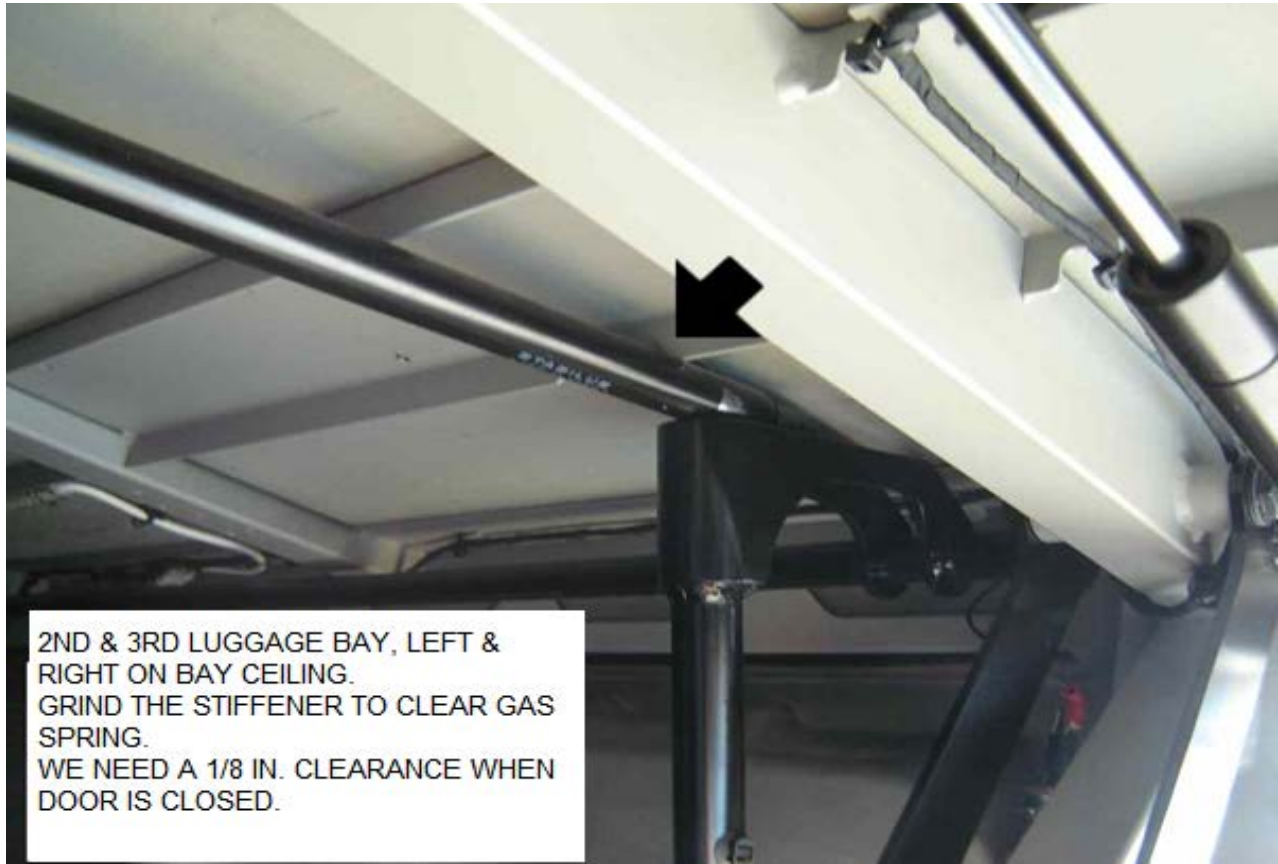
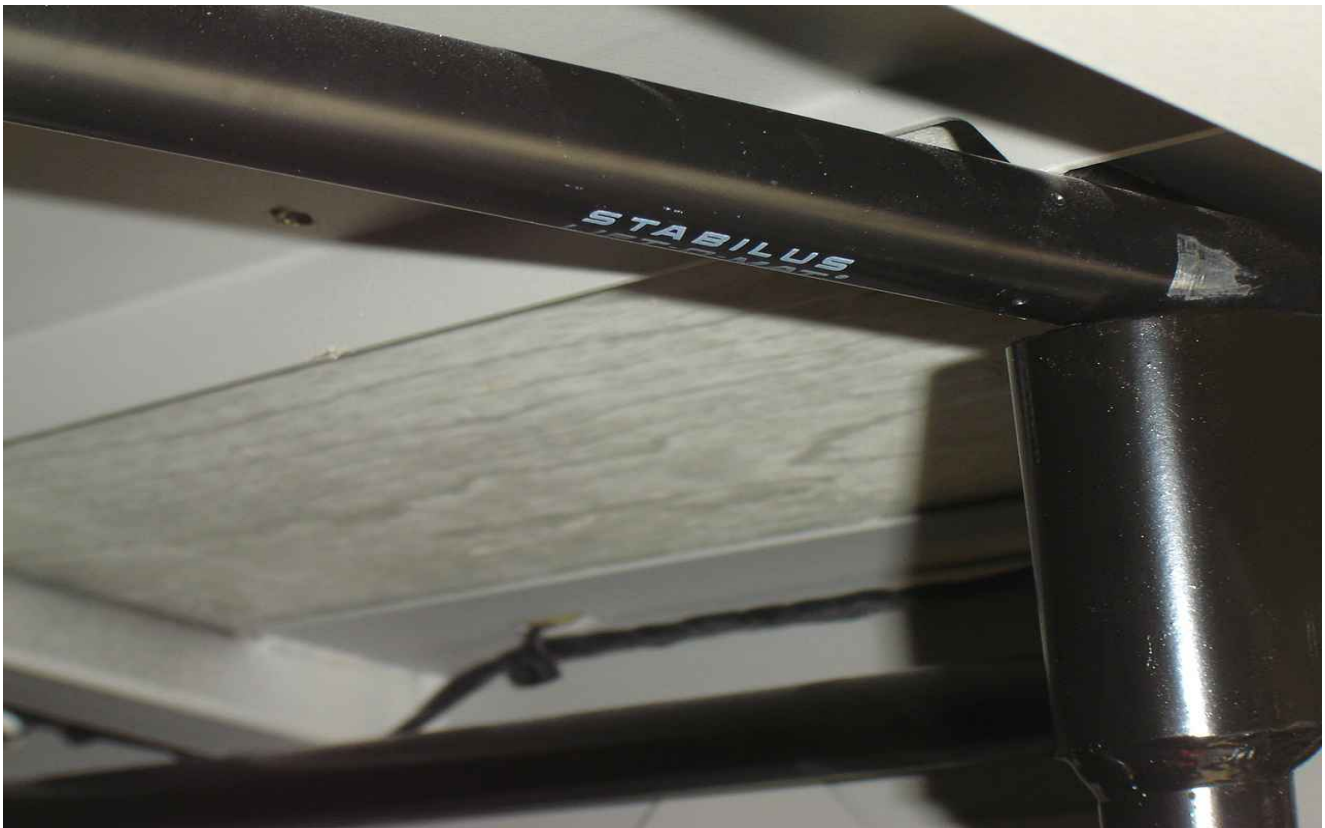
POSSIBLE INTERFERENCE BETWEEN STIFFENER FOR WCL RAIL WHEN LUGGAGE DOOR IS CLOSED.

INSPECT EACH GAS CYLINDER TO MAKE SURE THERE IS NO INTERFERENCE WITH THE PASSENGER'S FLOOR STIFFENERS WHEN LUGGAGE DOOR IS CLOSED.

THERE MUST REMAIN AT LEAST A 1/8IN (3MM) BEND ON THE STIFFENER AFTER GRINDING ELSE INFORM MAURICE GAGNÉ'S SERVICE TEAM BY PROVIDING DOOR POSITION AND VEHICLE NUMBER.

IF THERE IS INTERFERENCE, GRIND THE STIFFENER TO GET A CLEARANCE OF 1/8 IN. MINIMUM WITH CYLINDER.

PROTECT & MASK LUGGAGE BAY TO AVOID SPREAD OF METALLIC DUST.

TOUCH-UP PAINT: STRUCTURAL GRAY **688034**
