SP13-44 LIGHT SWITCH IN BAGGAGE COMPARTMENT  
REFER TO SAP FOR CODES AND VEHICLES  
VEUILLEZ VOUS RÉFÉRER AU RETROFIT R13056 POUR LA VERSION FRANCAISE

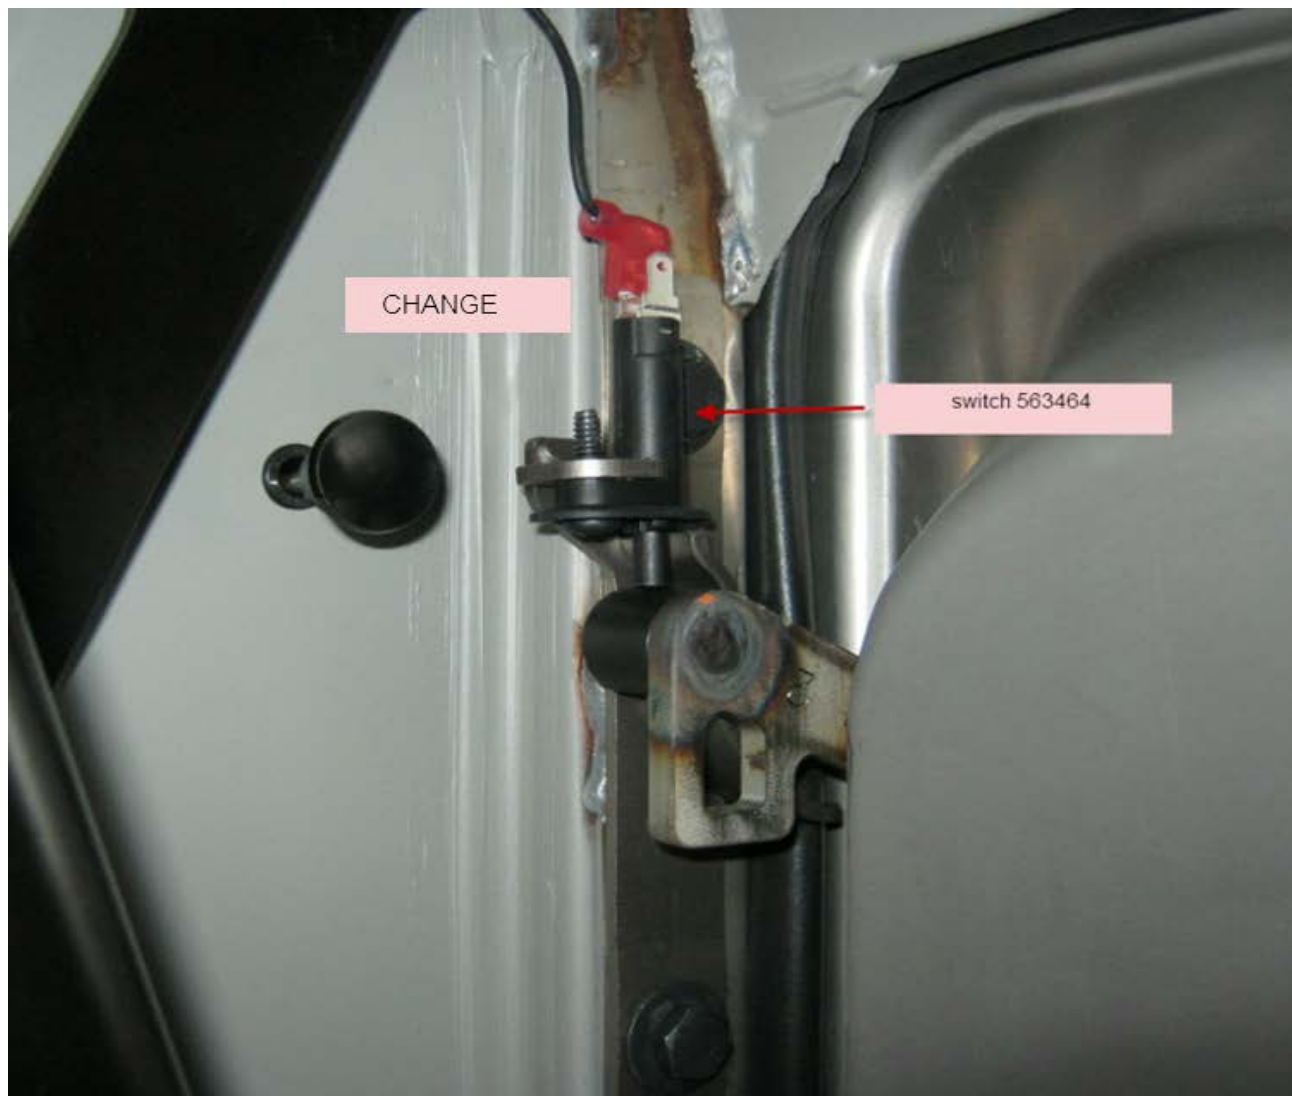
LIGHT SWITCH MAY OPERATE INCORRECTLY WHEN DOORS ARE CLOSED.

LIGHTS REMAIN "ON" INDEFINITELY.

IN THE BAGGAGE COMPARTMENTS CHANGE ALL 563424 SWITCHES BY 562303 (6 TOTAL), EXCEPT FOR THE WCL DOOR (ALREADY HAS THE NEW SWITCH).

CHECK PROPER OPERATION AFTER REPLACING THE SWITCHES

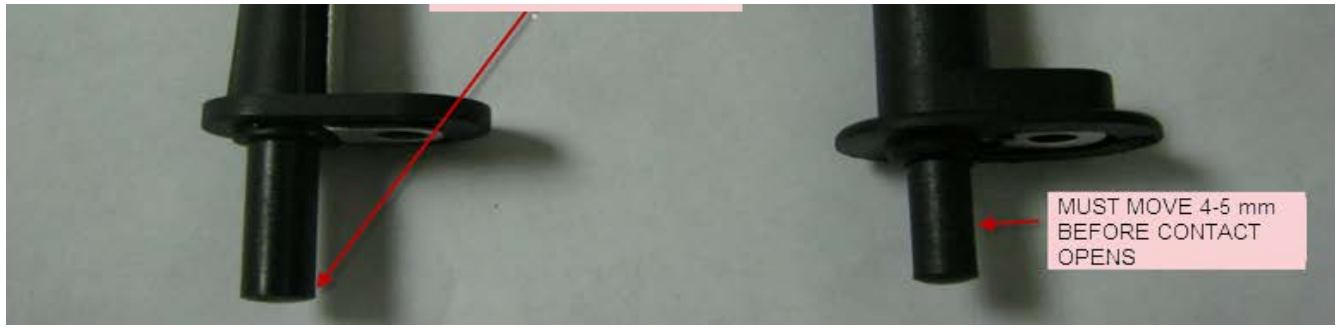
MUST MOVE 4-5 mm  
BEFORE CONTACT  
OPENS
