SP13-52 WELD INSPECTION OF TOP FAN SUPPORT

RISK OF PREMATURE FAILURE OF TOP FAN SUPPORT DUE TO ABSENCE OF WELD.
REFER TO SAP FOR VEHICLES AND CODES.
POUR LA VERSION FRANCAISE DE CETTE PROCÉDURE, VEUILLEZ VOUS REFERER AU RETROFIT
PRODUCTION R13072.

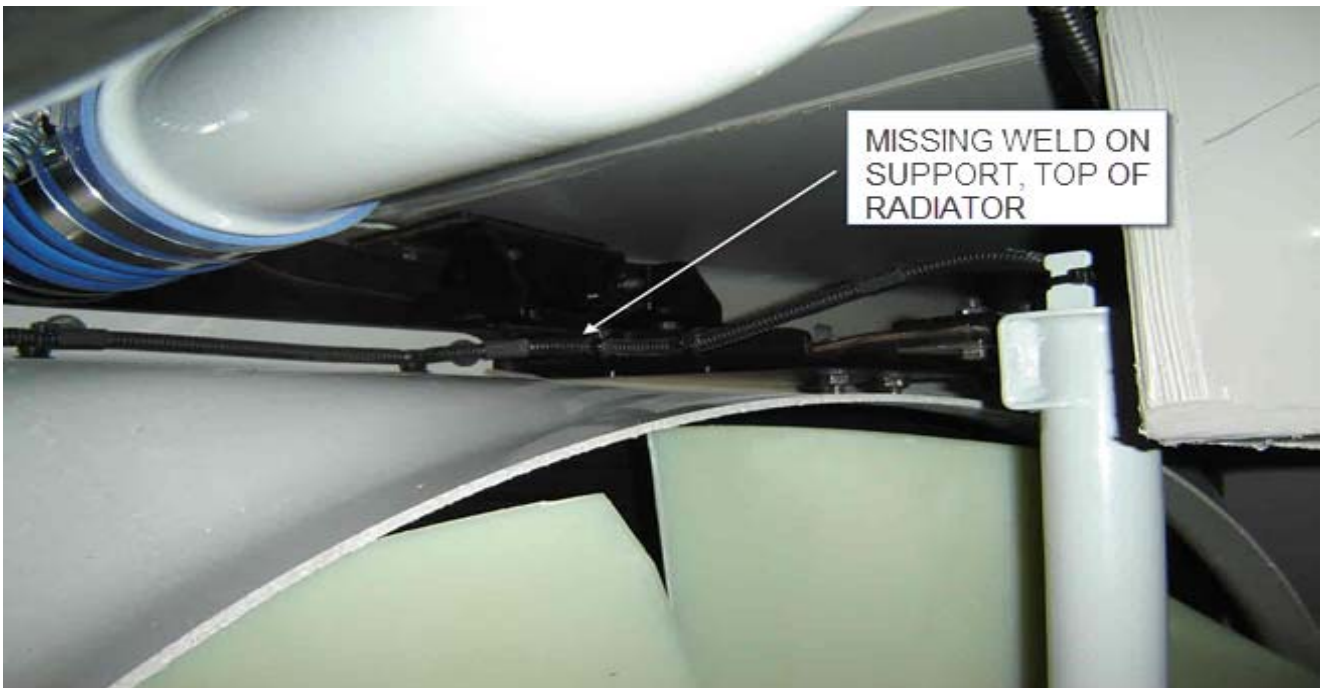
IN THE ENGINE COMPARTMENT ABOVE RADIATOR, INSPECT SUPPORT TO MAKE SURE SUPPORT
HAS TWO WELDS IN THE CORNERS (SEE PHOTO)

USE A TELESCOPIC MIRROR TO INSPECT. IF THERE IS NO WELD, REPLACE **053024**
