Subject		Market
Occupant Classification Calibration Utility Error after Repair		USA
Service Category	Section	
Vehicle Interior	Supplemental Restraint Systems	
Applicability		
2013-2014 GS Models 2013-2014 ES Models

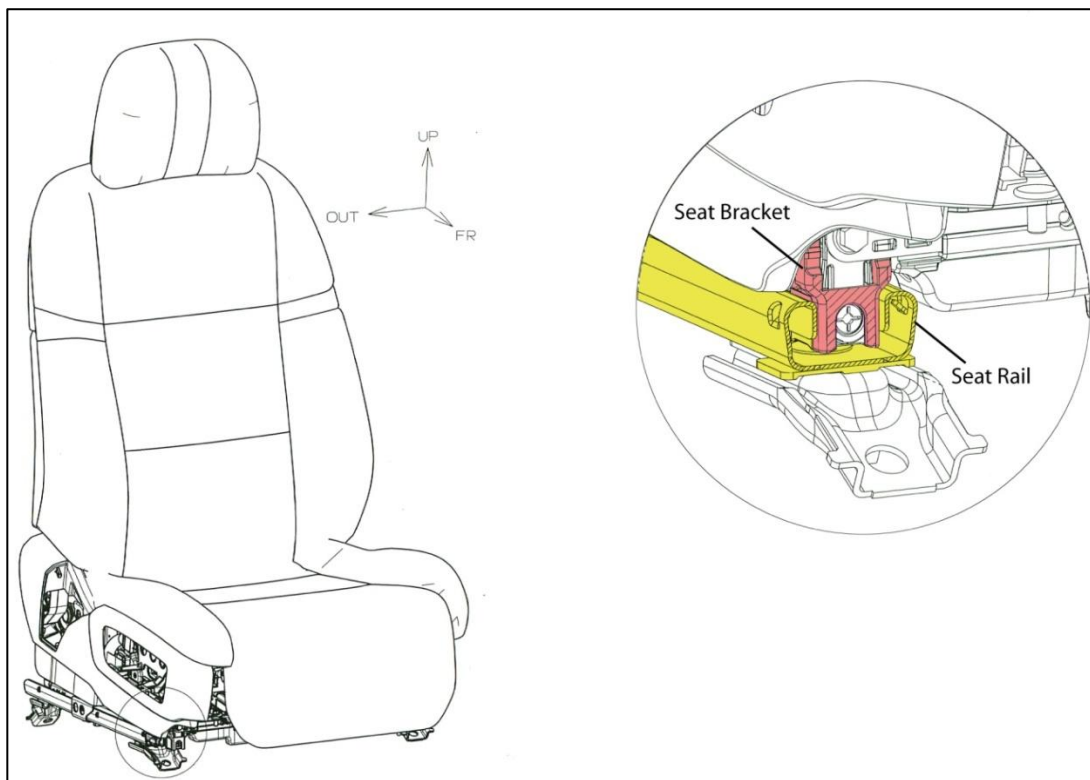
When performing the Zero Point Calibration & Sensitivity Check on the models noted above, an error will occur if user follows on-screen instructions. This issue is being investigated for release in a future software version.

Move the seat forward until the seat bracket and the seat rail are flush, as shown in the picture below. Failure to do this will result in the utility failing.
